Mountains Recreation and Conservation Authority

Corral, Escondido, & Ramirez Canyon, Latigo Parking and Malibu Bluffs

September 21, 2009

Southwestern Engineering Geology

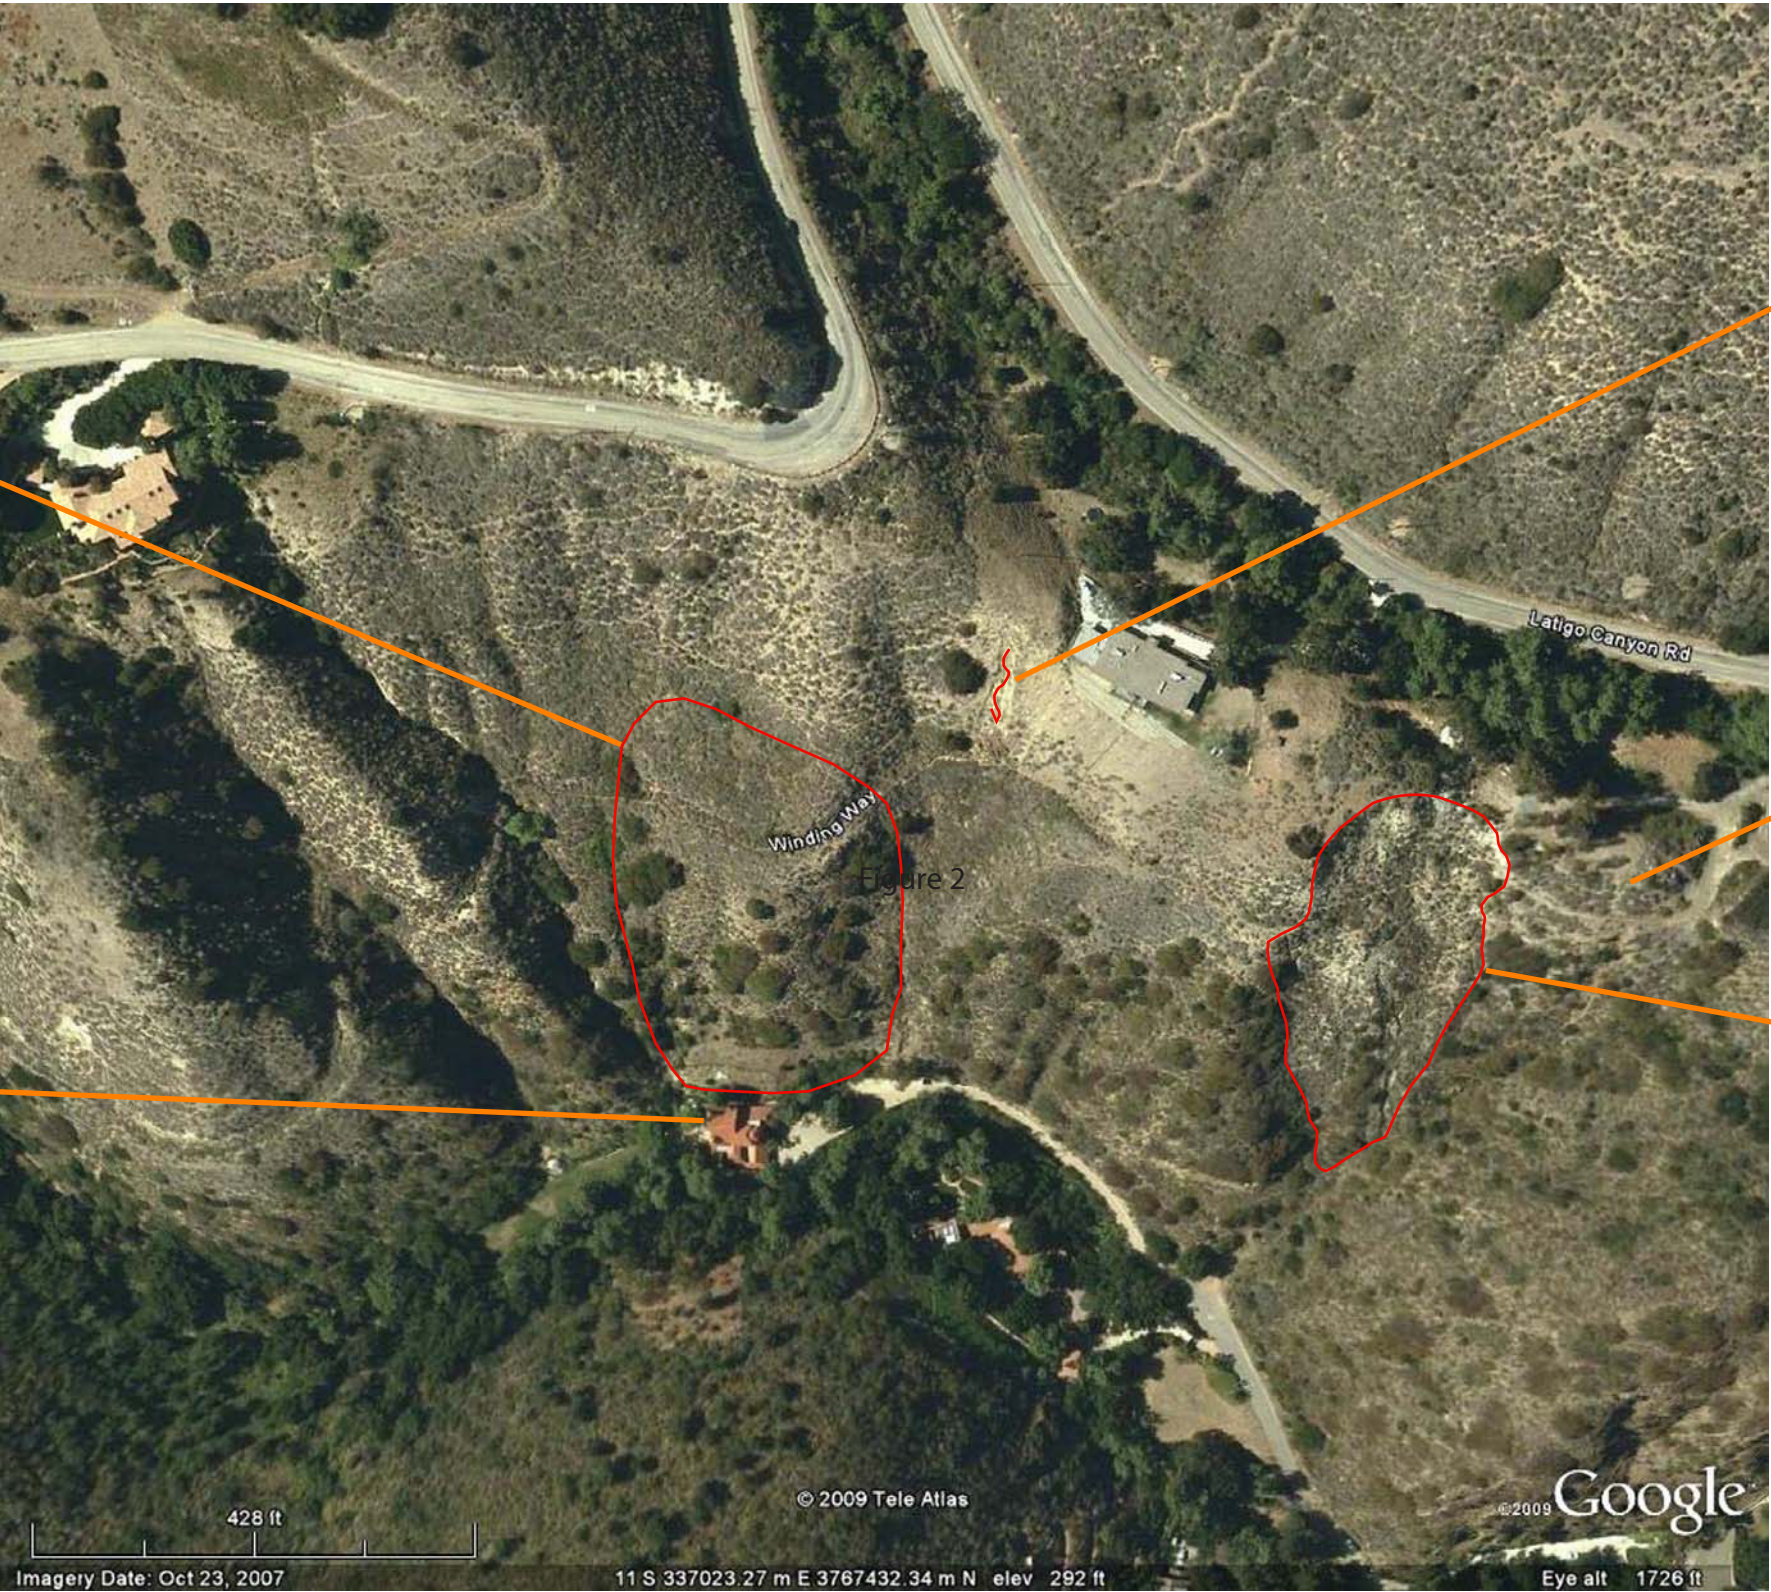
Figure 5

Approximate boundaries as published on small scale maps by Campbell et. al. (1970) and on Dibblee (1993b). Geomorphology suggests boundaries that extend further west as recognized in consultant studies (California GeoSystems, 1985a)

Existing Debris Flow  
Note that snout of debris blocks existing bench.

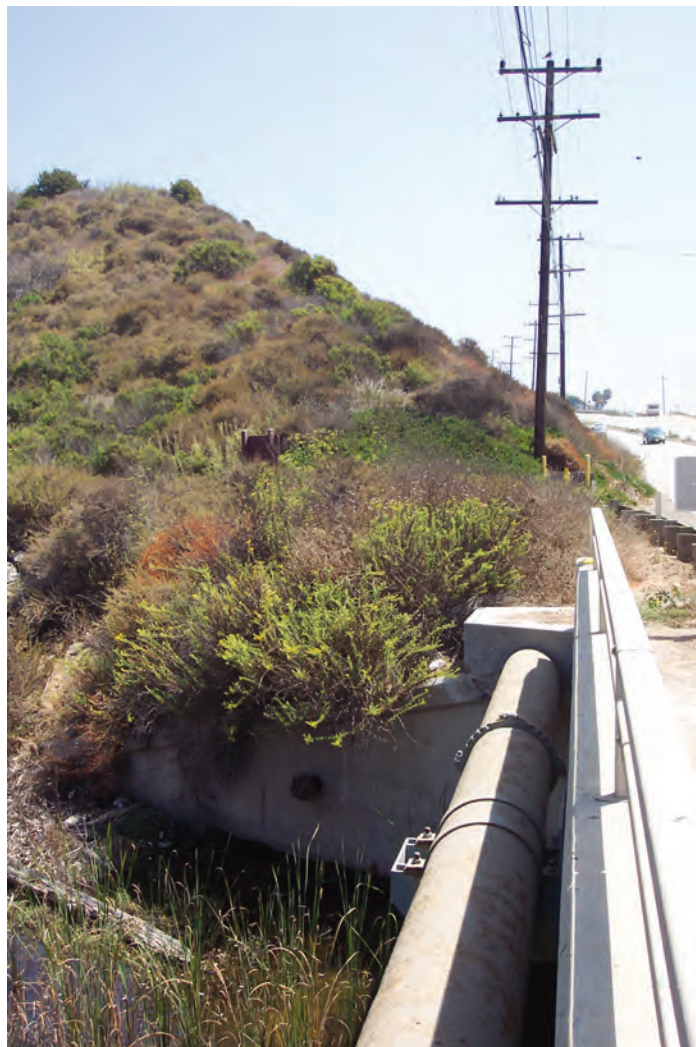
Photo 1 - Water line, retaining wall and road fill at proposed trailhead parking area at Pacific Coast Highway at Corral Canyon.

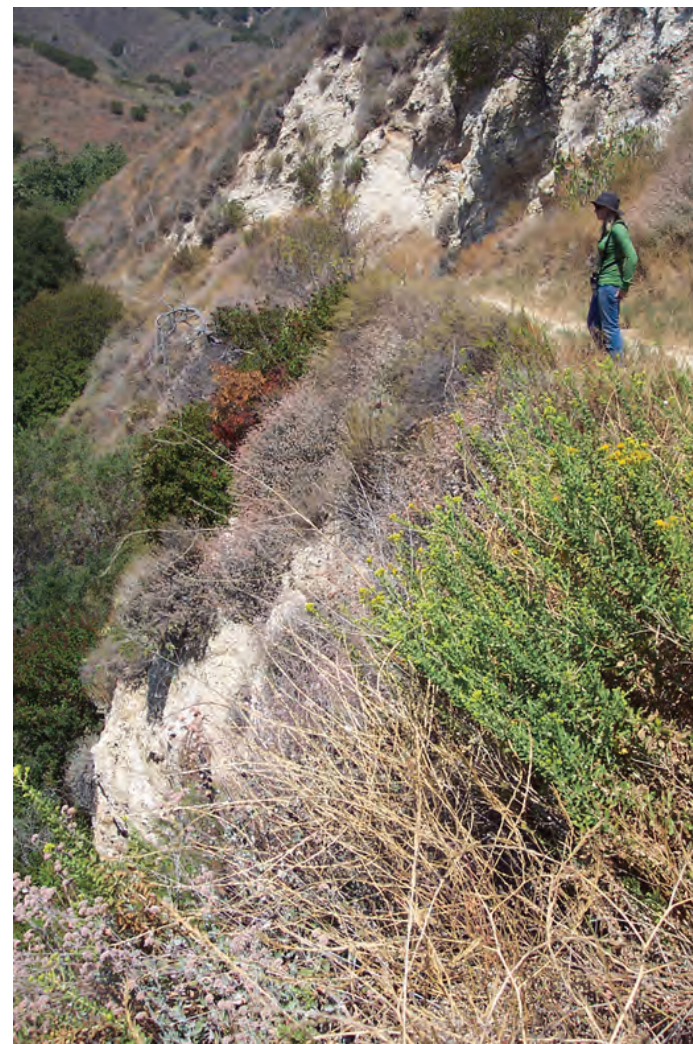
Photo 2 - Existing trail along steep slope at Location 3, Corral Canyon.

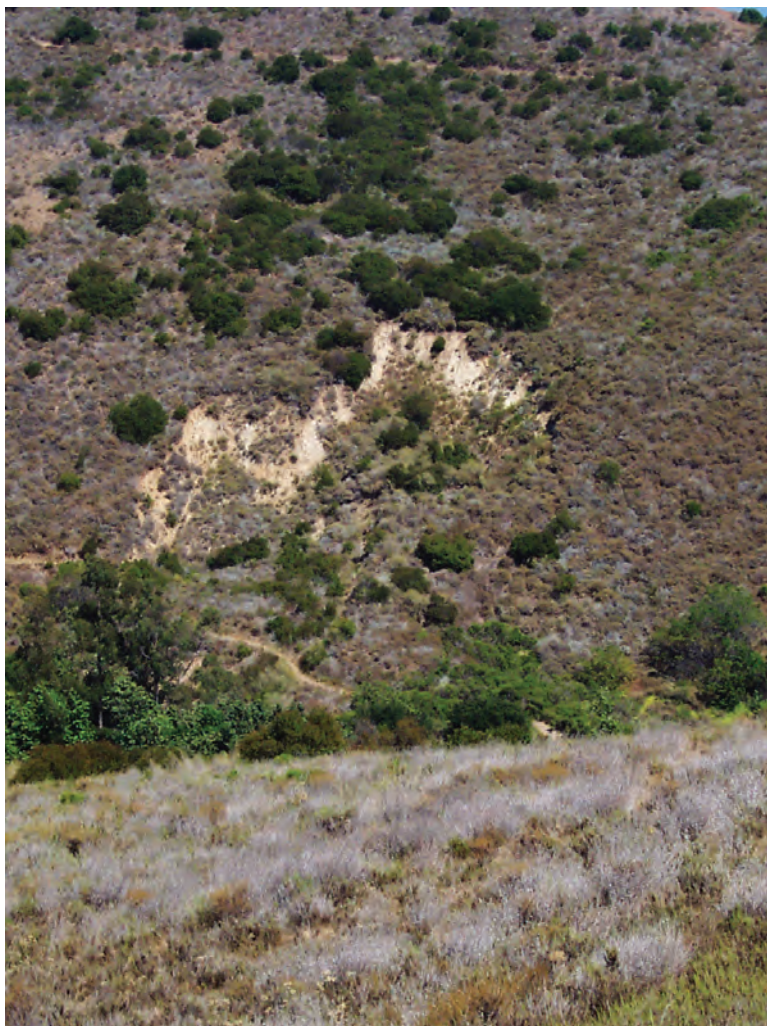
Photo 3 - Recently active landslide just north of Camp Area 2.

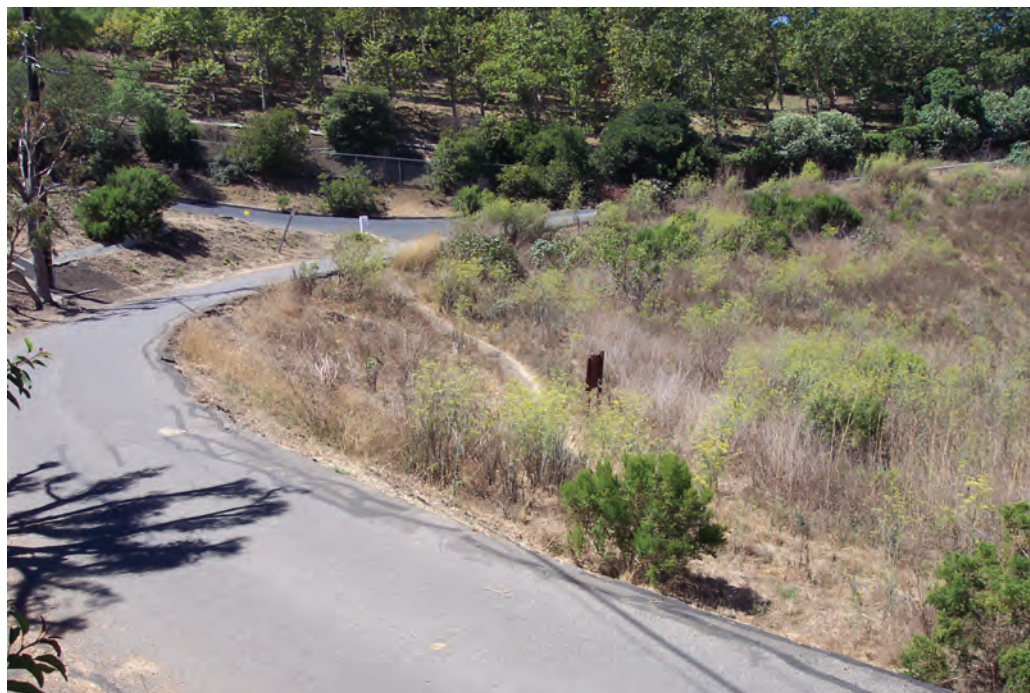
Photo 4 - Vicinity of proposed 15,000 sf parking area near trailhead at Escondido Canyon. Constructing parking area may require substantial grading. Road cracks suggests fill settlement and possible downhill creep. The road and descending slope were resurfaced prior to September, 2009.

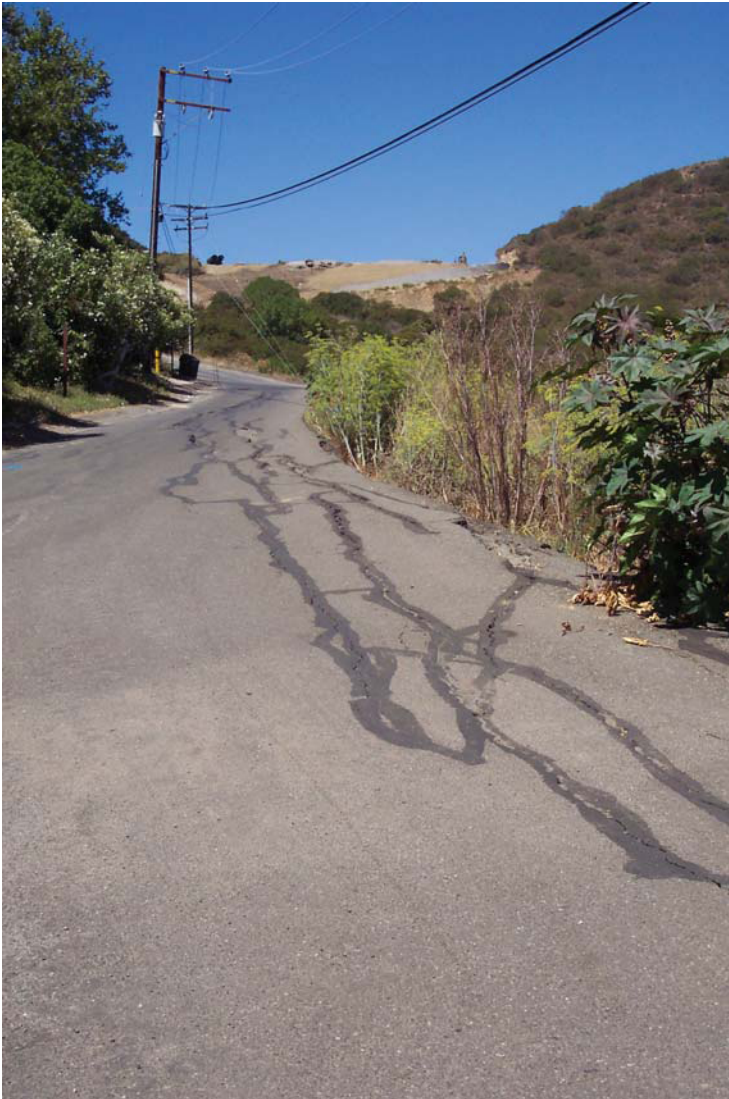
Photo 5 - Closer view of cracking along Winding Way. The outer five to ten feet of the roadway are affected. Road was resurfaced prior to our site reconnaissance in September 2009.

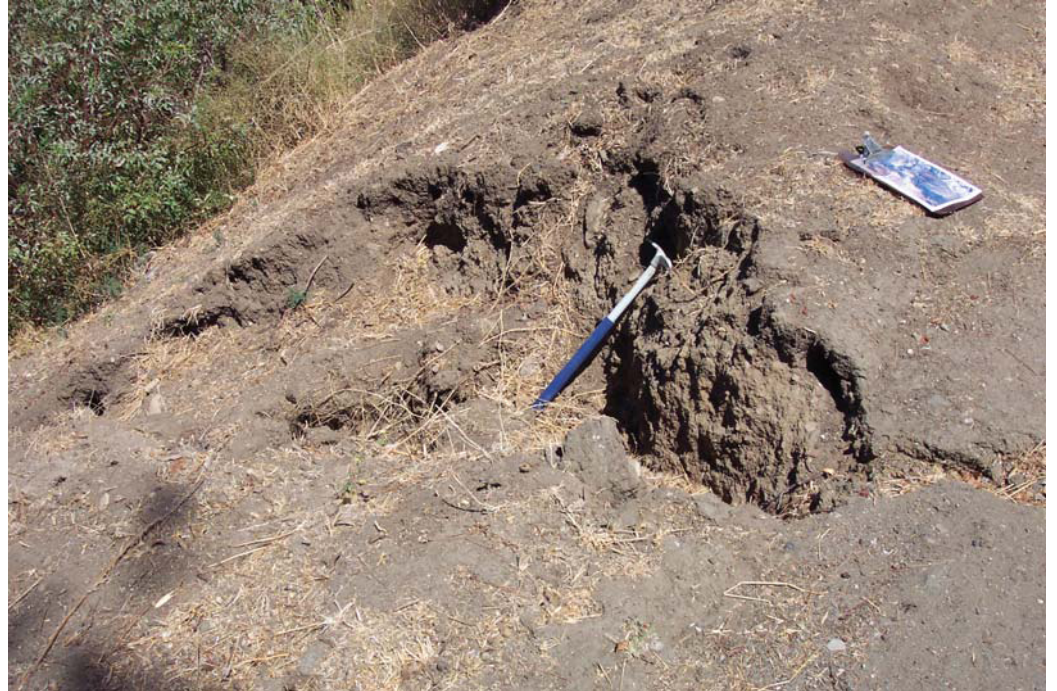
Photo 6 - Erosion due to concentrated drainage across existing maintenance road at Escondido Canyon between trailhead and ADA Camp Area.

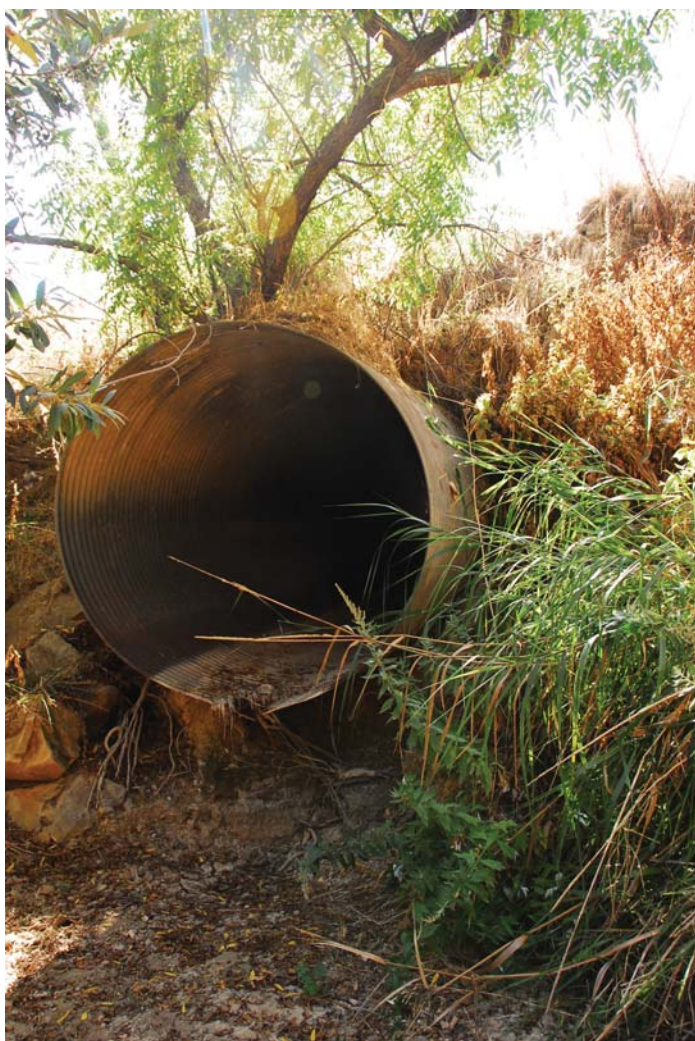
Photo 7 - Outfall of pipe that carries flow along Escondido Creek below crossing for access road. Surrounding fill is eroded to a steep angle to vertical.

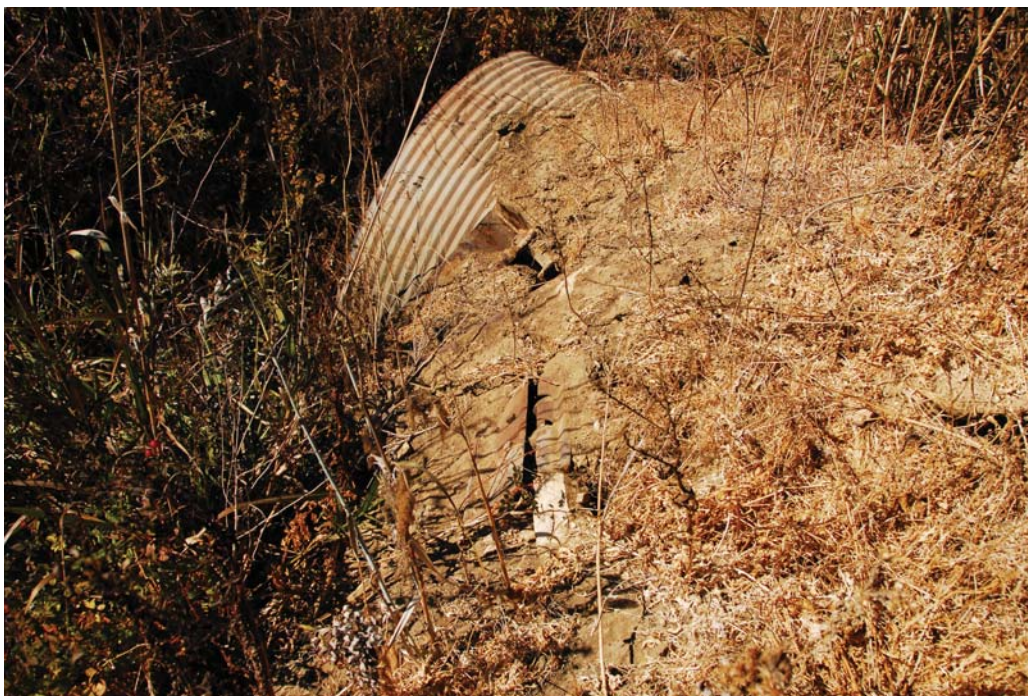
Photo 8 - Inlet to pipe that carries flow along Escondido Creek below crossing for access road. Note fill contains debris including old tracks from heavy equipment.

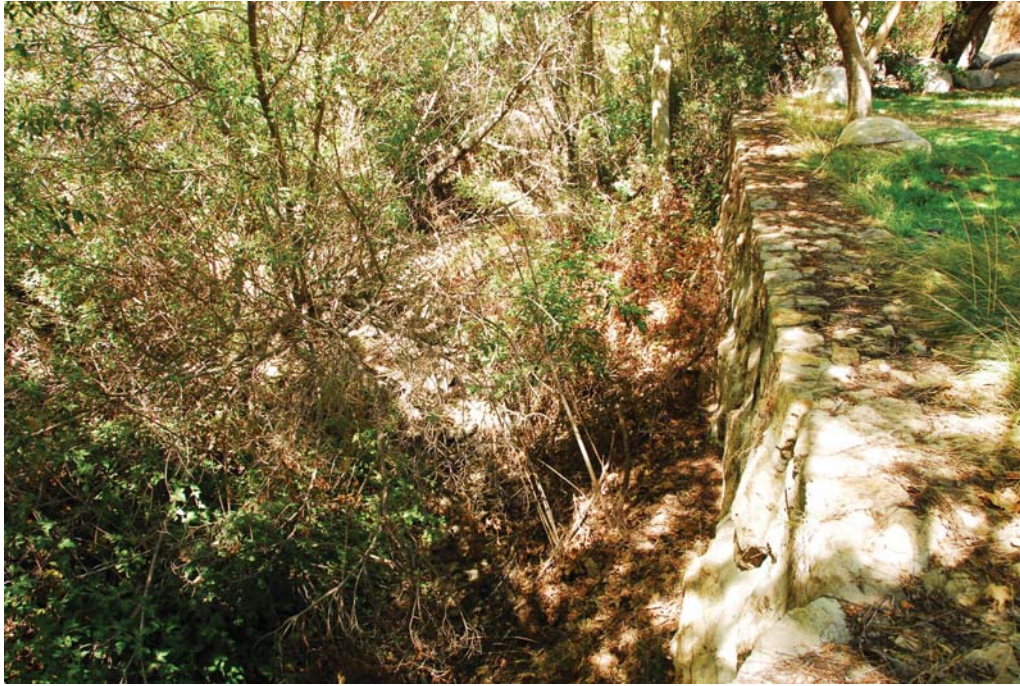
Photo 9- View looking north along rock retaining wall on east bank of Ramirez Canyon Creek at proposed bridge crossing. Wall is about 7 feet high, and is located about five feet above the streambed.

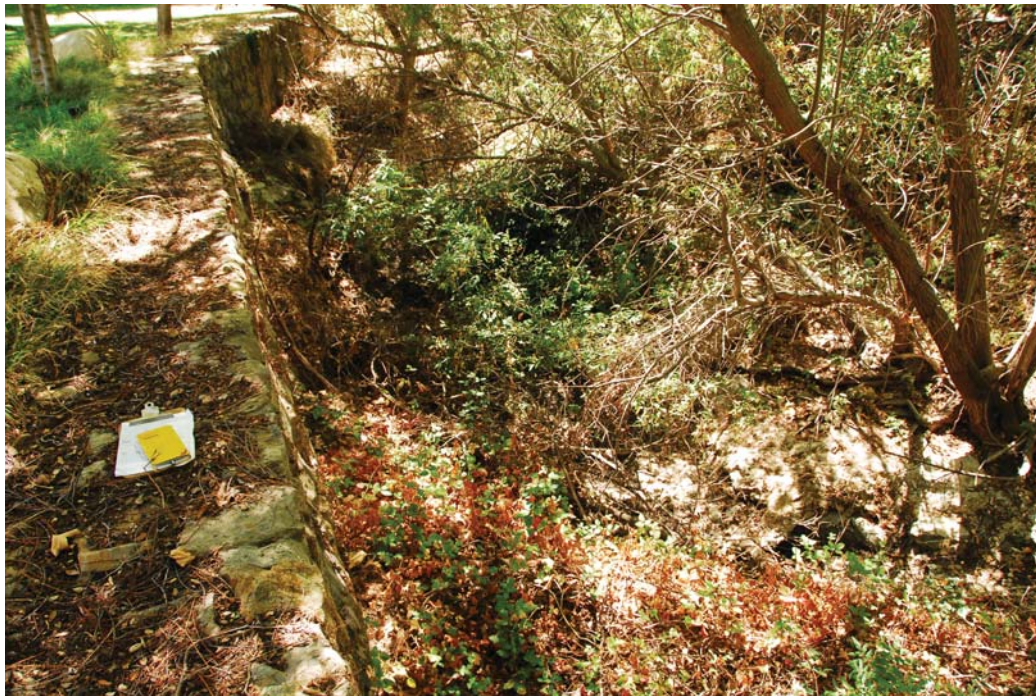
Photo 10 - View looking south along rock retaining wall on east bank of Ramirez Canyon Creek at proposed bridge crossing. Creek encroaches within about five feet of the wall.

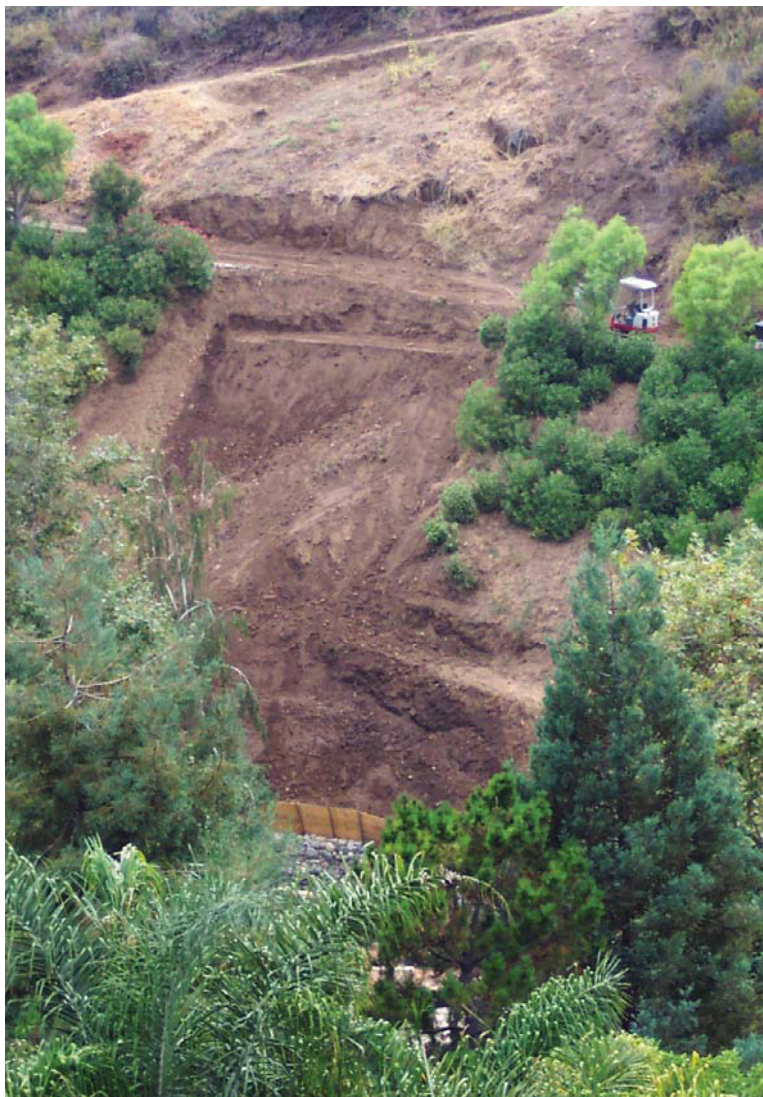
Photo 11 - Slope repair upslope of the "Barwood" under repair in 2006.

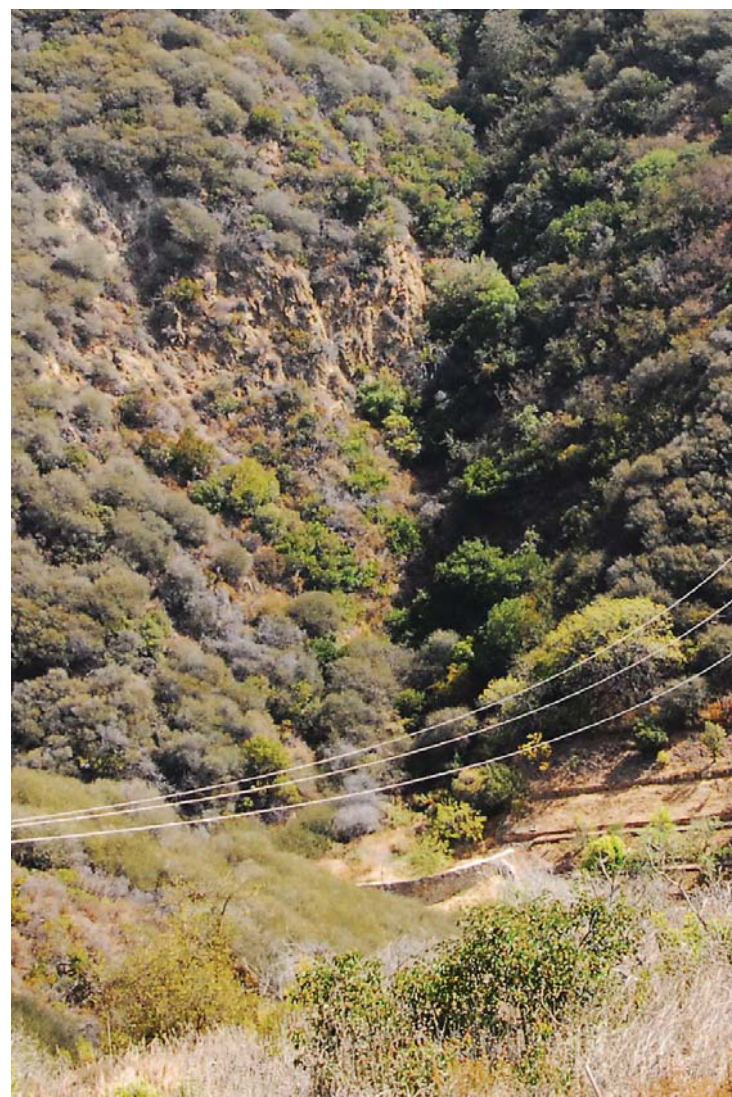
Photo 12 - Steep, rocky outcrop above camp area proposed at Note 8 on Plate 3B. A potential for large topples and rockfall from this outcrop preclude camp areas at the bottom of the canyon (above the wall) or in the meadow north of the adjacent protective ridge.

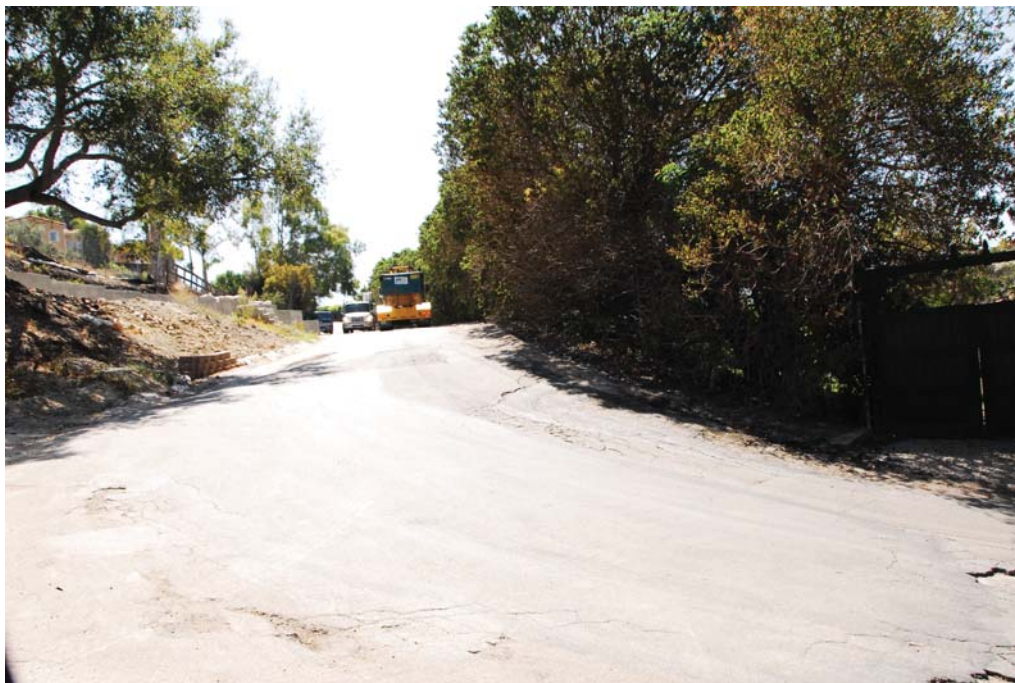
Photo 13- View looking south along upper section of Delaplane Road. Slopes ascend and descend from the edge of the existing pavement at a gradient of about 2:1.

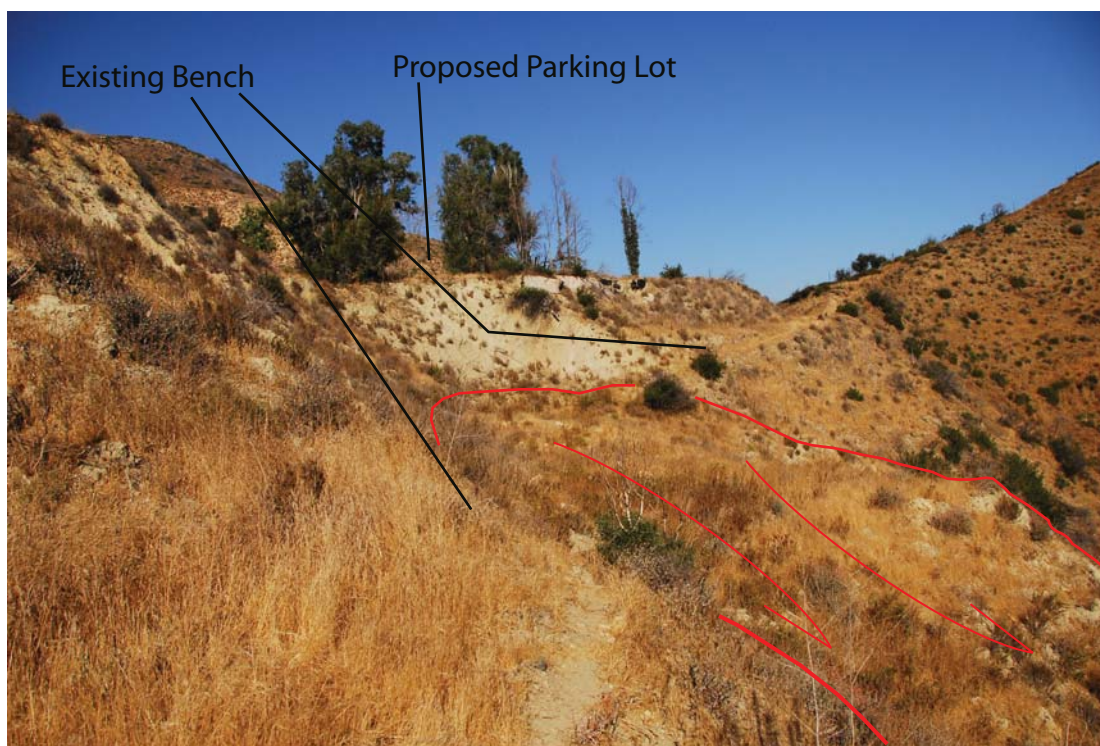
Photo 14 - View looking east across landslide south of proposed parking area, showing headscarp and displacement of existing trail.

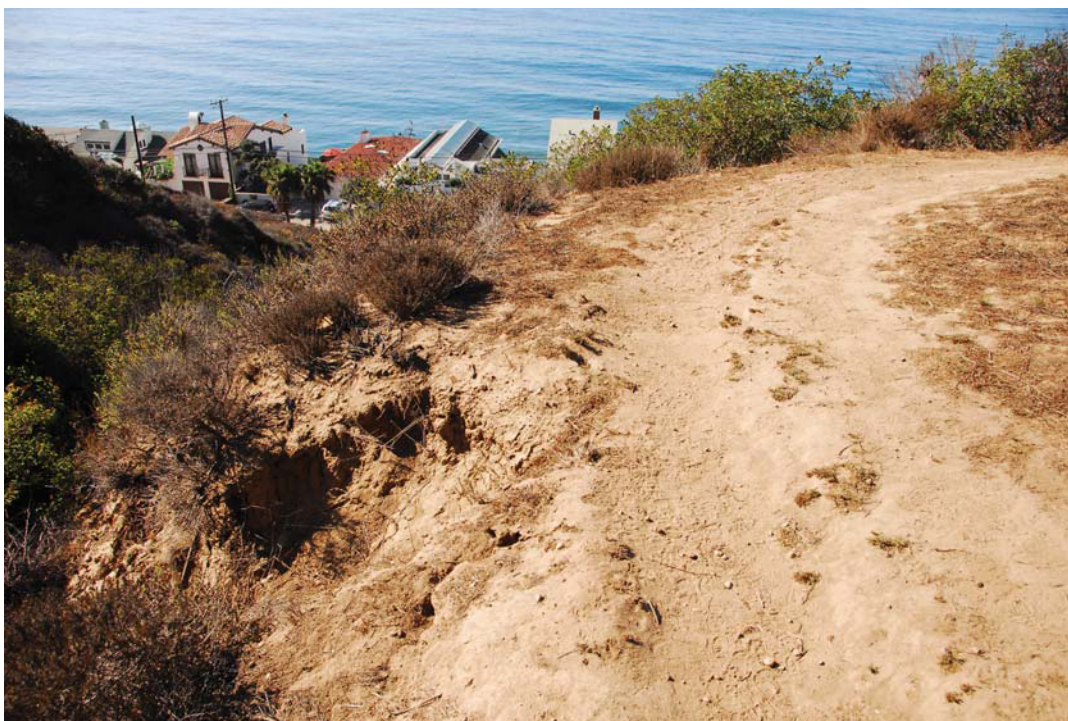
Photo 15 - Erosion encroaching into existing trail along blufftop.

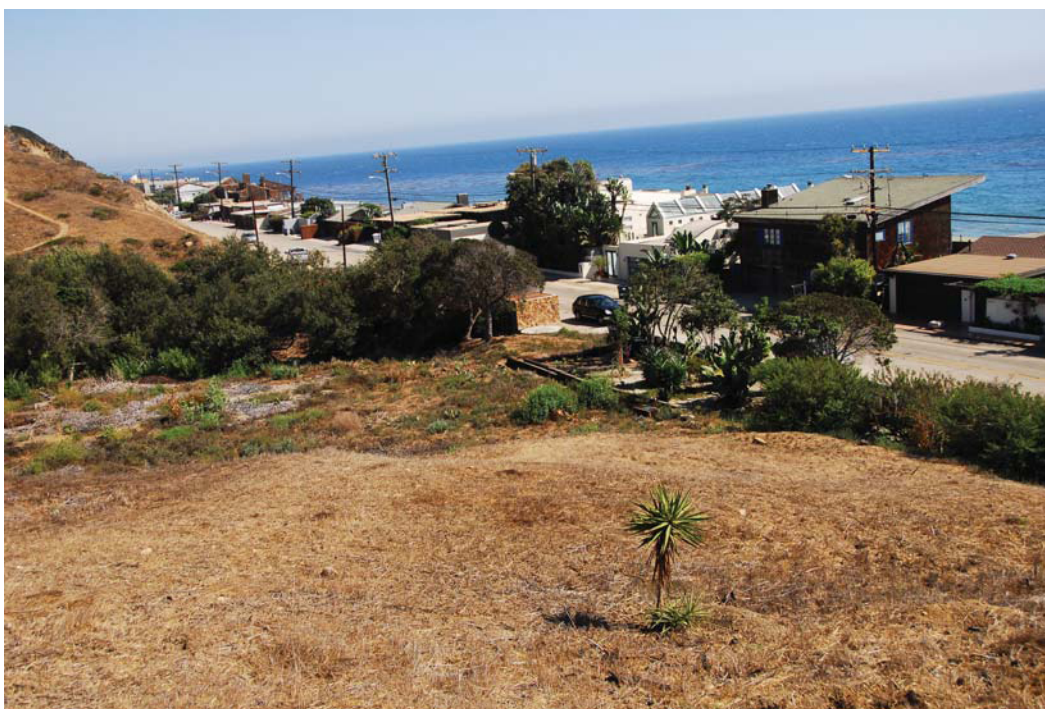
Photo 16 - Existing garden surrounded by railroad ties at grade of Malibu Road where small parking area is proposed. Slosson and Moran identified foreground of photo as ancient landslide.

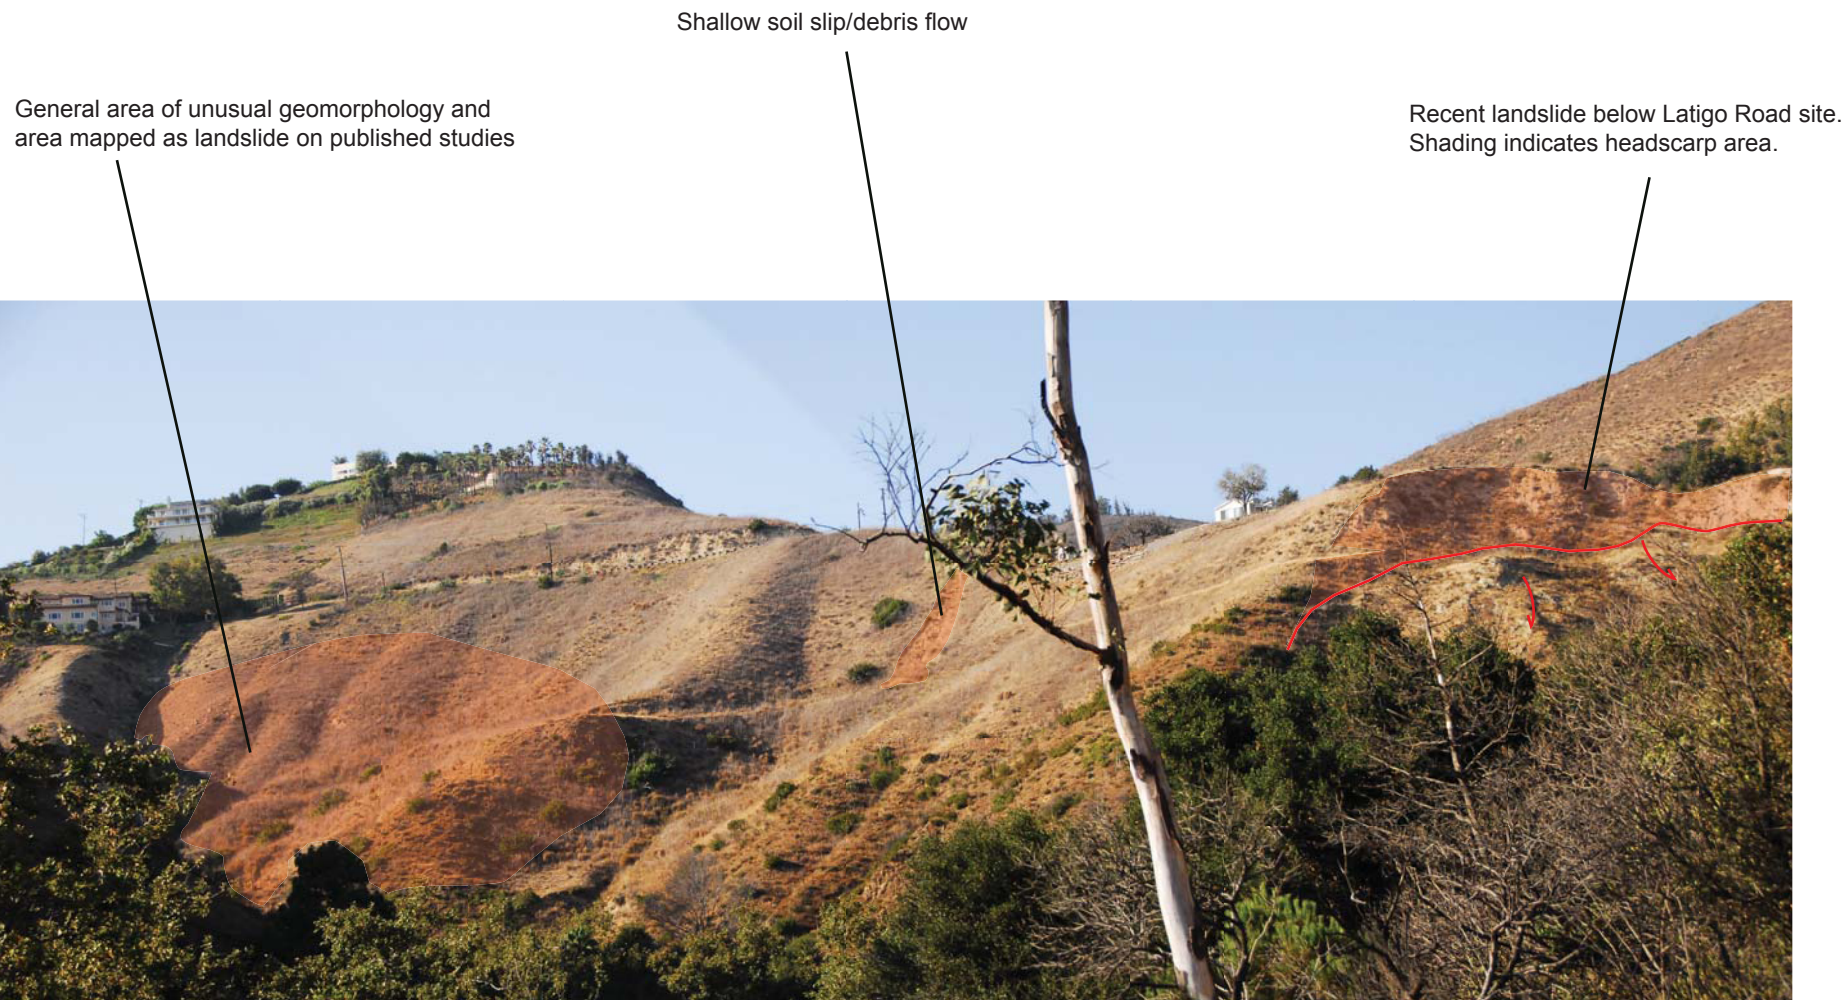
Photo 17 - Areas of slope instability west of the parking area proposed along Latigo Canyon Road. Recent landslide below Latigo site is at right side of photo, a shallow soil slip/debris flow near the photo center, and a general area where a landslide is indicated on published studies in the left third of the photo.
