<b>MOUNTAINS RECREATION AND CONSERVATION AUTHORITY GRANT APPLICATION</b>				
<b>Project Name:</b> Camp Hess Kramer and Gindling Hilltop Camp Fire Rebuild		<b>Amount of Request:</b>	\$ \$12,250,000	
<b>Applicant Name:</b> Wilshire Temple Boulevard		<b>Total Project Cost:</b>	\$ 52+ million	
<b>Applicant Address:</b> 11495 and 11677 Pacific Coast Highway Malibu, CA 90265		<b>Amount of Match:</b>		
		<b>Source of Match:</b>	Various	
<b>Project Address:</b> 11495 and 11677 Pacific Coast Highway Malibu, CA 90265 (cross street/entrance off Yerba Buena)				
<b>Email:</b>	doug@wbtcamps.org	<b>COUNTY</b>	<b>SENATE</b>	<b>ASSEMBLY</b>
<b>Phone:</b>	(213) 835-2141	Ventura County	23	44
<b>Grantee's Authorized Representative:</b>				
Donna Nadel, Executive Director of Wilshire Boulevard		(213) 835-2141		
<i>Name and Title</i>		<i>Phone</i>		
<b>Person with day-to-day responsibility for project:</b>				
Douglas Lynn, Executive Director: Camps and Conference Center		(213) 835-2142

**WILSHIRE BOULEVARD TEMPLE  
CAMP HESS KRAMER & GINDLING HILLTOP CAMP FIRE REBUILD BUDGET**

**Reference: Camp Hess Kramer and Gindling Hilltop Camps  
Wilshire Boulevard Temple**

Gindling Hilltop Camp and Camp Hess

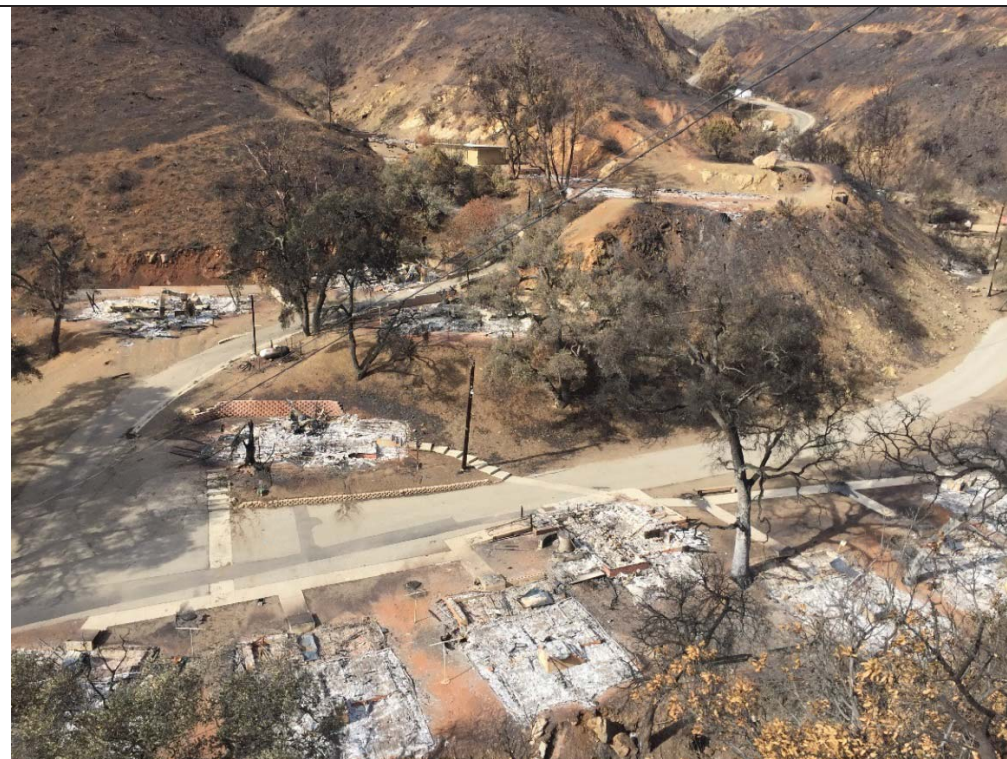
Photo of Middle Camp cabins area immediately after Woolsey Fire. The Fire destroyed 22 of the 24 structures in this area.

This photo was taken November 27, 2018 before it started raining. With the rains, significant erosion occurred, covering this and other areas with mud, boulders and debris.

Building remains were removed as part of the Department of Toxic Substances Control (DTSC) efforts.

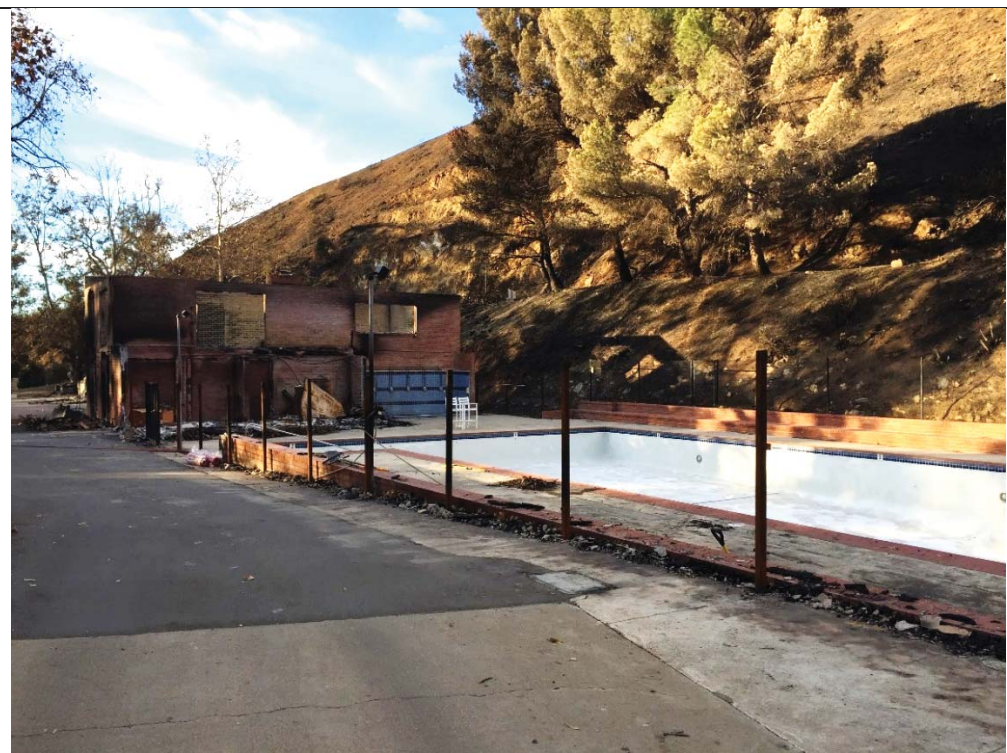
Baruh Hall was one of the many structures destroyed by fire. The swimming pool was later filled in entirely with mud and boulders after repeated heavy rains eroded the hillsides around Camp. The remains of the building were removed as part of the State's Department of Toxic Substances Control (DTSC) efforts.

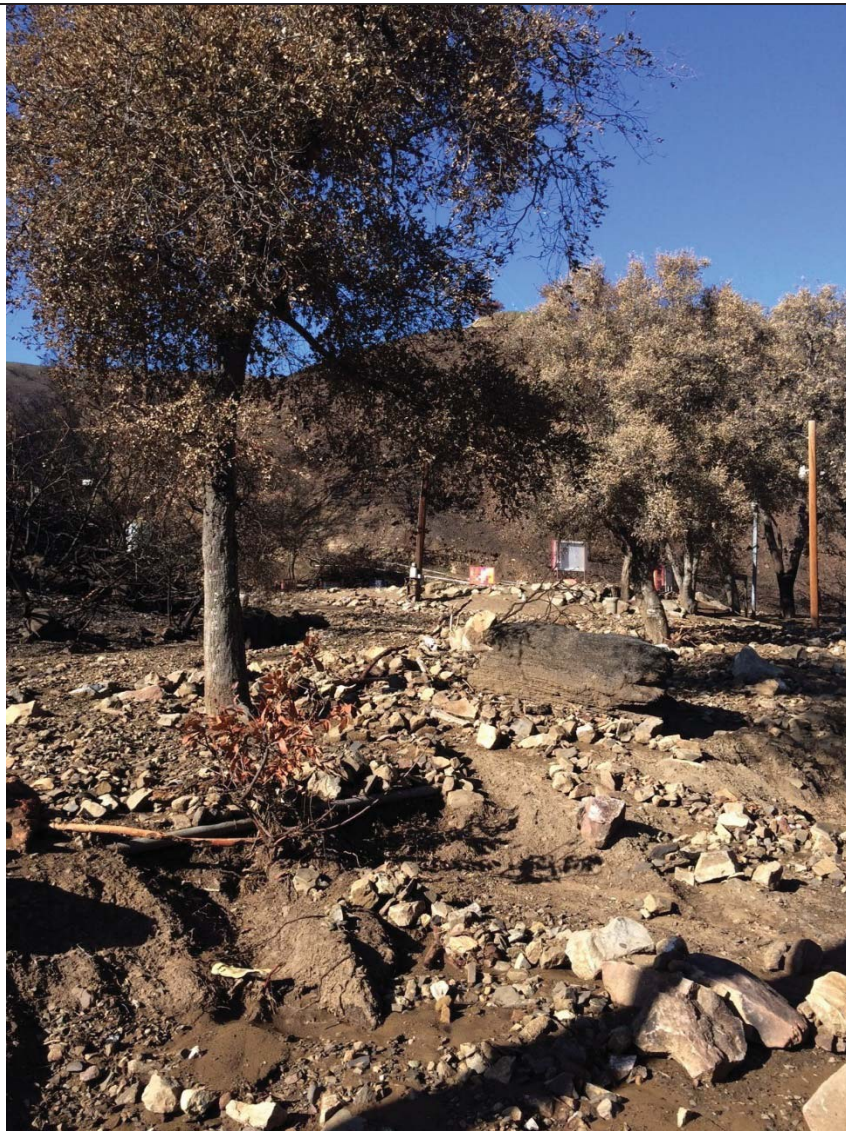
Outdoor areas such as at the north end of Middle Camp were entirely filled with mud and boulders during the subsequent rain events.

The area shown here included a bowl-shaped seating/gathering area and a stage, along with an access road to a water tank and shed that were destroyed.

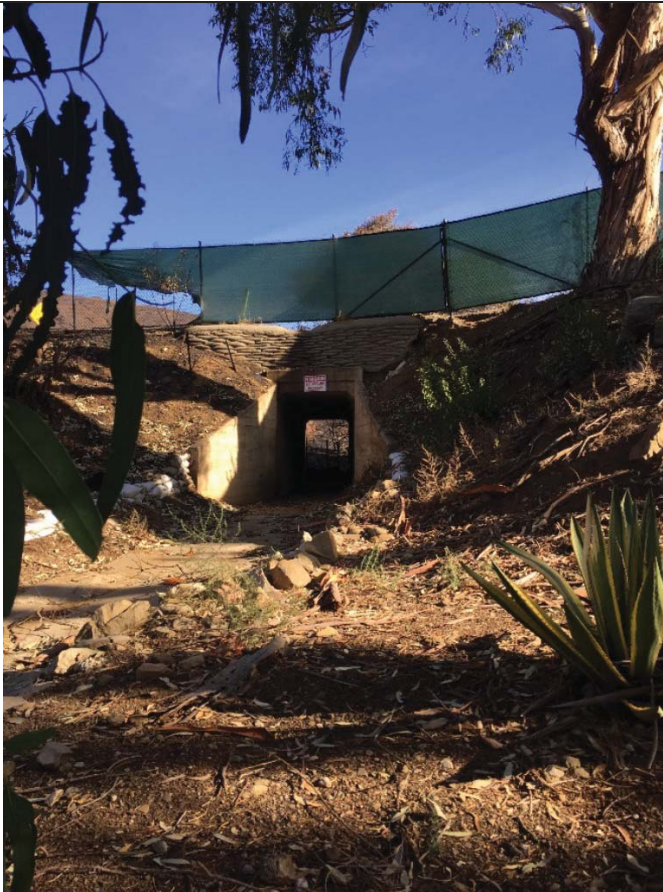
Culvert immediately after the fire.

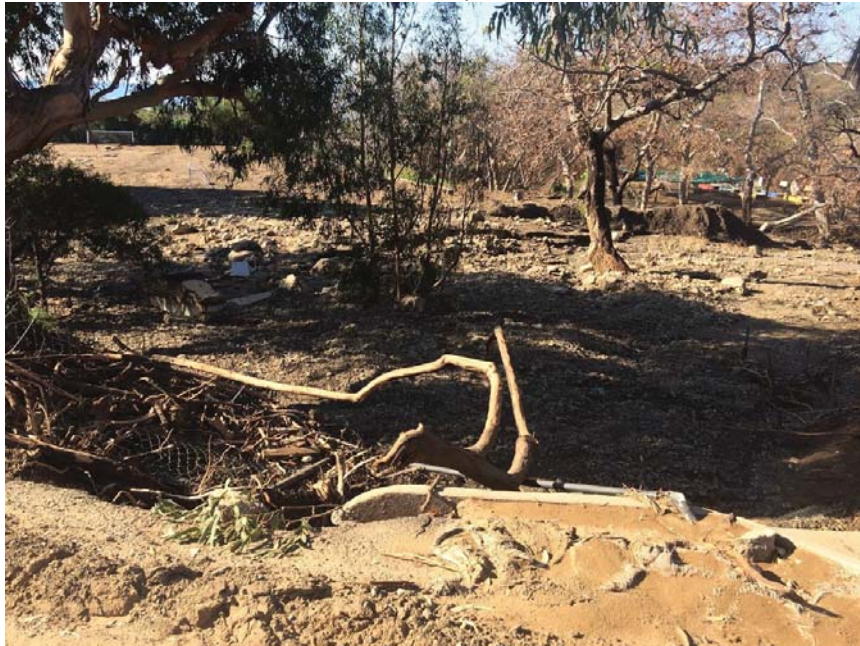
Looking toward Gil Fitch Field after mud and debris was deposited across a large land area after coming onto property through the culvert.

A culvert under Ye Buena Road brings stormwater from neighboring properties to the north and east across the site and to Little Sycamore Creek. This culvert was the conduit for a significant amount of mud entering the site during the post-fire rains. Mud covered Gil Fitch Field and damaged onsite roads and contributed to bank erosion on Little Sycamore Creek.

Unstable soils, boulders and stormwater coming from above this culvert are expected to continue to make their way on site until the watershed recovers and after.

An engineered solution to this issue, and to convey future stormwater will be part of the rebuild project.

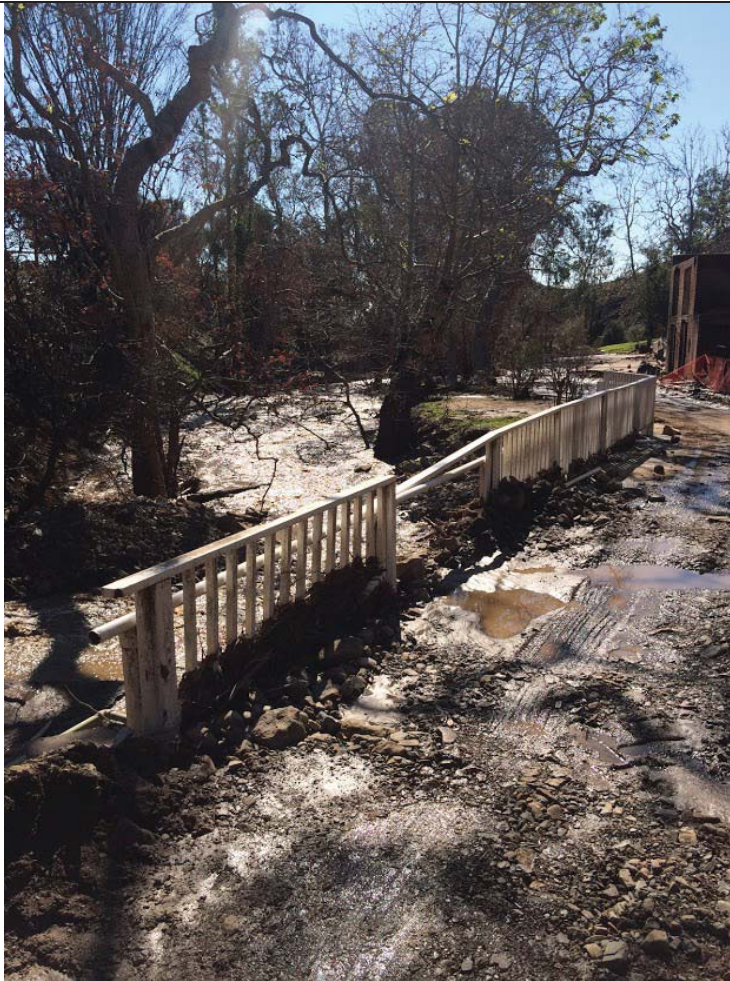
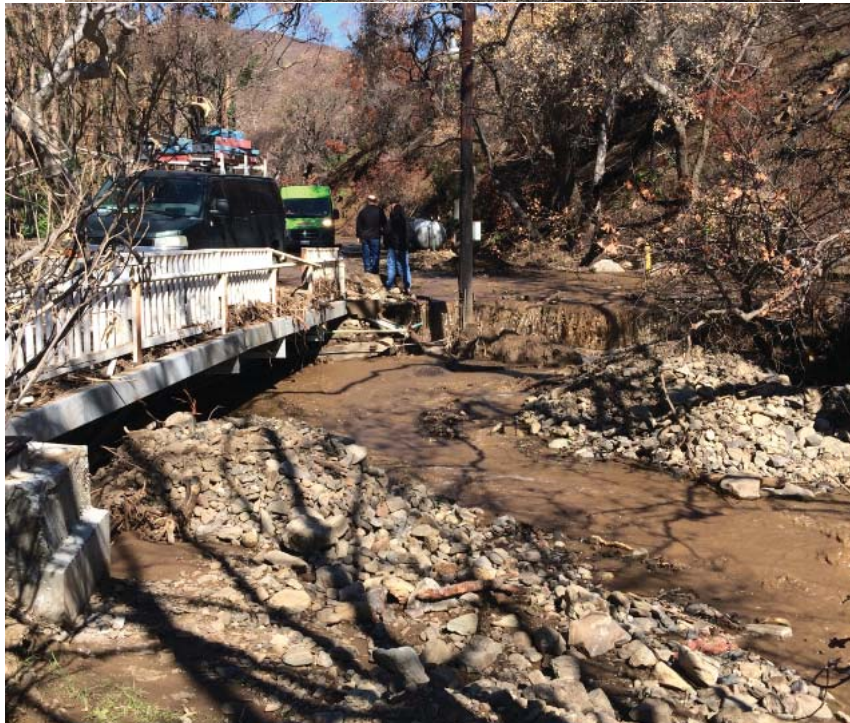
Little Sycamore Creek  
filled in with mud from  
bank to bank. Mud then  
overflowed the banks  
and covered and  
damaged the bridges.  
This photo was taken  
prior to mud taking out  
the railings. As the creek  
filled its banks, it also  
found alternative routes  
around these bridges.

Mud and stormwater  
damaged some program  
spaces and structures in  
lower camp that had not  
been destroyed by fire  
such as an arts and  
crafts area.

Erosion along the Creek  
also damaged the main  
parking area. The banks  
and the perimeter of the  
parking spaces were  
washed away.

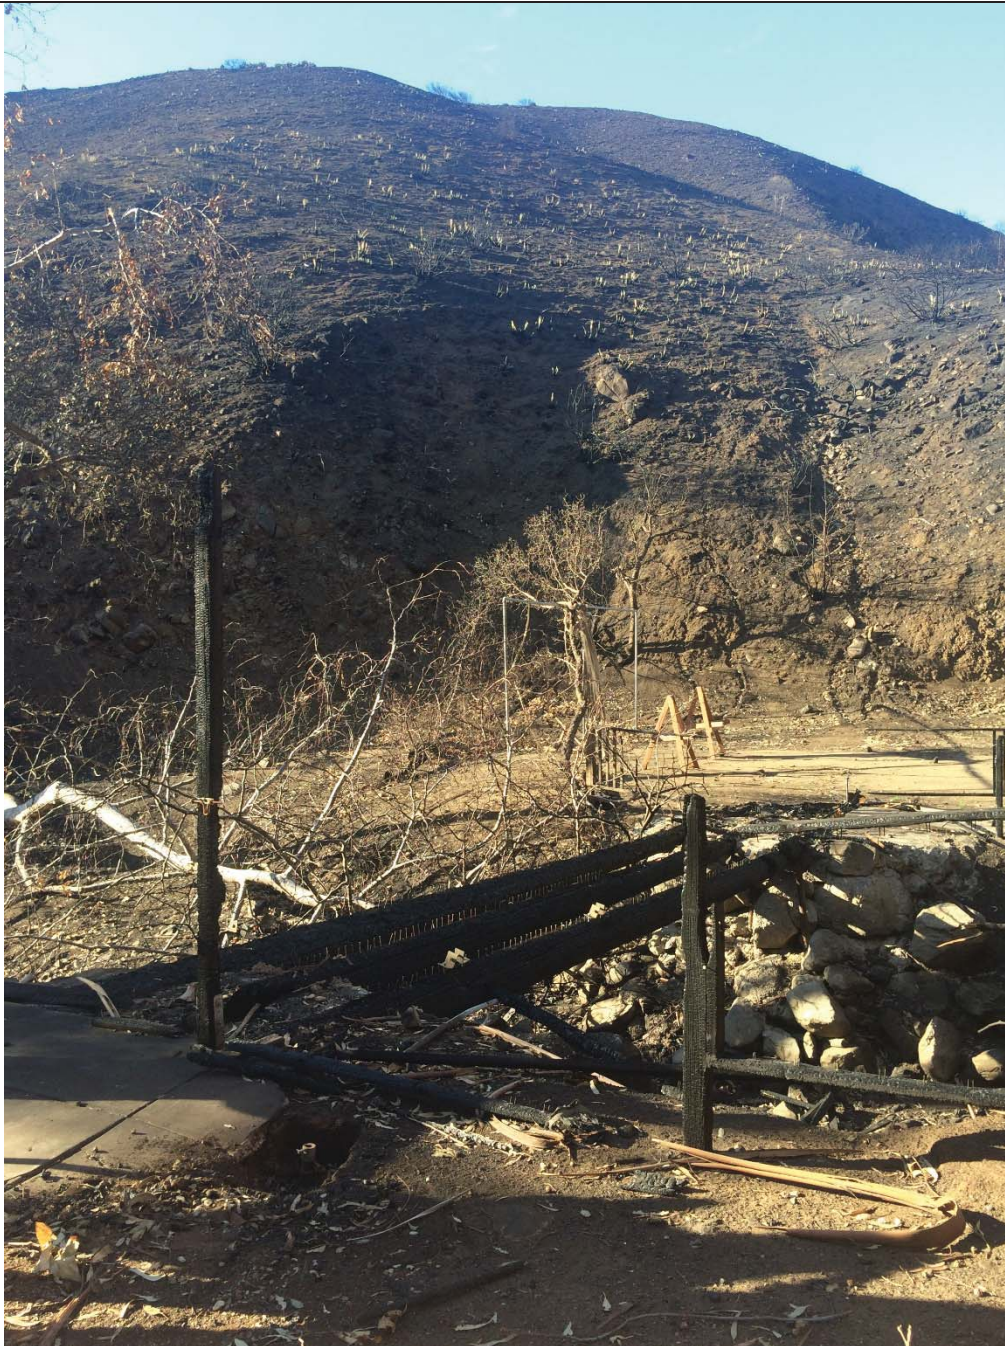
In addition to vehicle bridges, Camp had two pedestrian bridges, one in lower and one in middle camp, connecting to flat program spaces west of the Creek. These pedestrian bridges were both burned by fire and further destroyed by subsequent storm events.

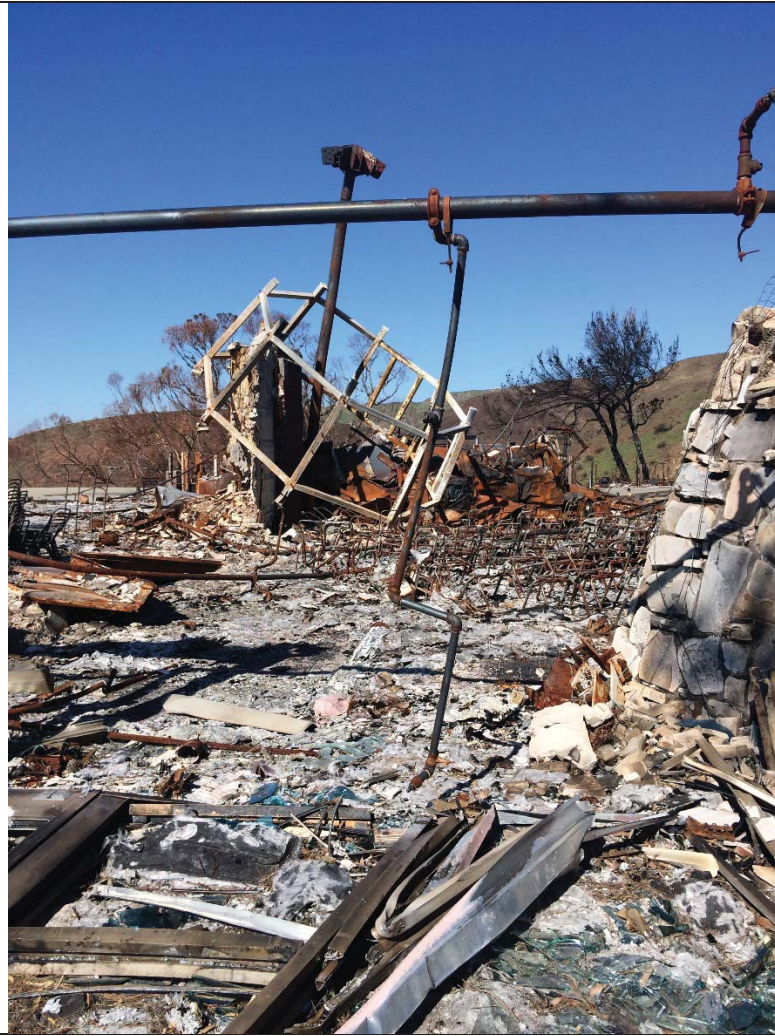
The fire destroyed 12 out of 15 structures, and some metal storage containers at Gindling Hilltop or "Upper Camp." This picture shows the remains of the 8,000SF Dining Pavilion.

The remains of these structures were removed as part of the State's debris removal program.

Unlike the middle and lower camps, Gindling is not along the creek, and is not surrounded by steep slopes above. Erosion of the hillsides below Gindling however did impact the access road and some repairs will need to be made to the access road in addition to rebuilding structures.
