Reconnaissance and Geotechnical Update; Proposed
Trail Improvements Between Murphy Way and Escondido
Canyon

Southwestern Engineering Geology

SUBJECT: RECONNAISSANCE AND GEOTECHNICAL UPDATE REPORT; PROPOSED TRAIL IMPROVEMENTS BETWEEN MURPHY WAY AND ESCONDIDO CANYON, CITY OF MALIBU; CALIFORNIA.

**RECONNAISSANCE OF ENGINEERING GEOLOGIC CONSTRAINTS
PROPOSED PARK, PARKING & TRAIL IMPROVEMENTS
RAMIREZ CANYON, ESCONDIDO CANYON, CORRAL CANYON,
ALONG LATIGO CANYON ROAD AND AT MALIBU BLUFF STATE PARK
CITY OF MALIBU, CALIFORNIA.**

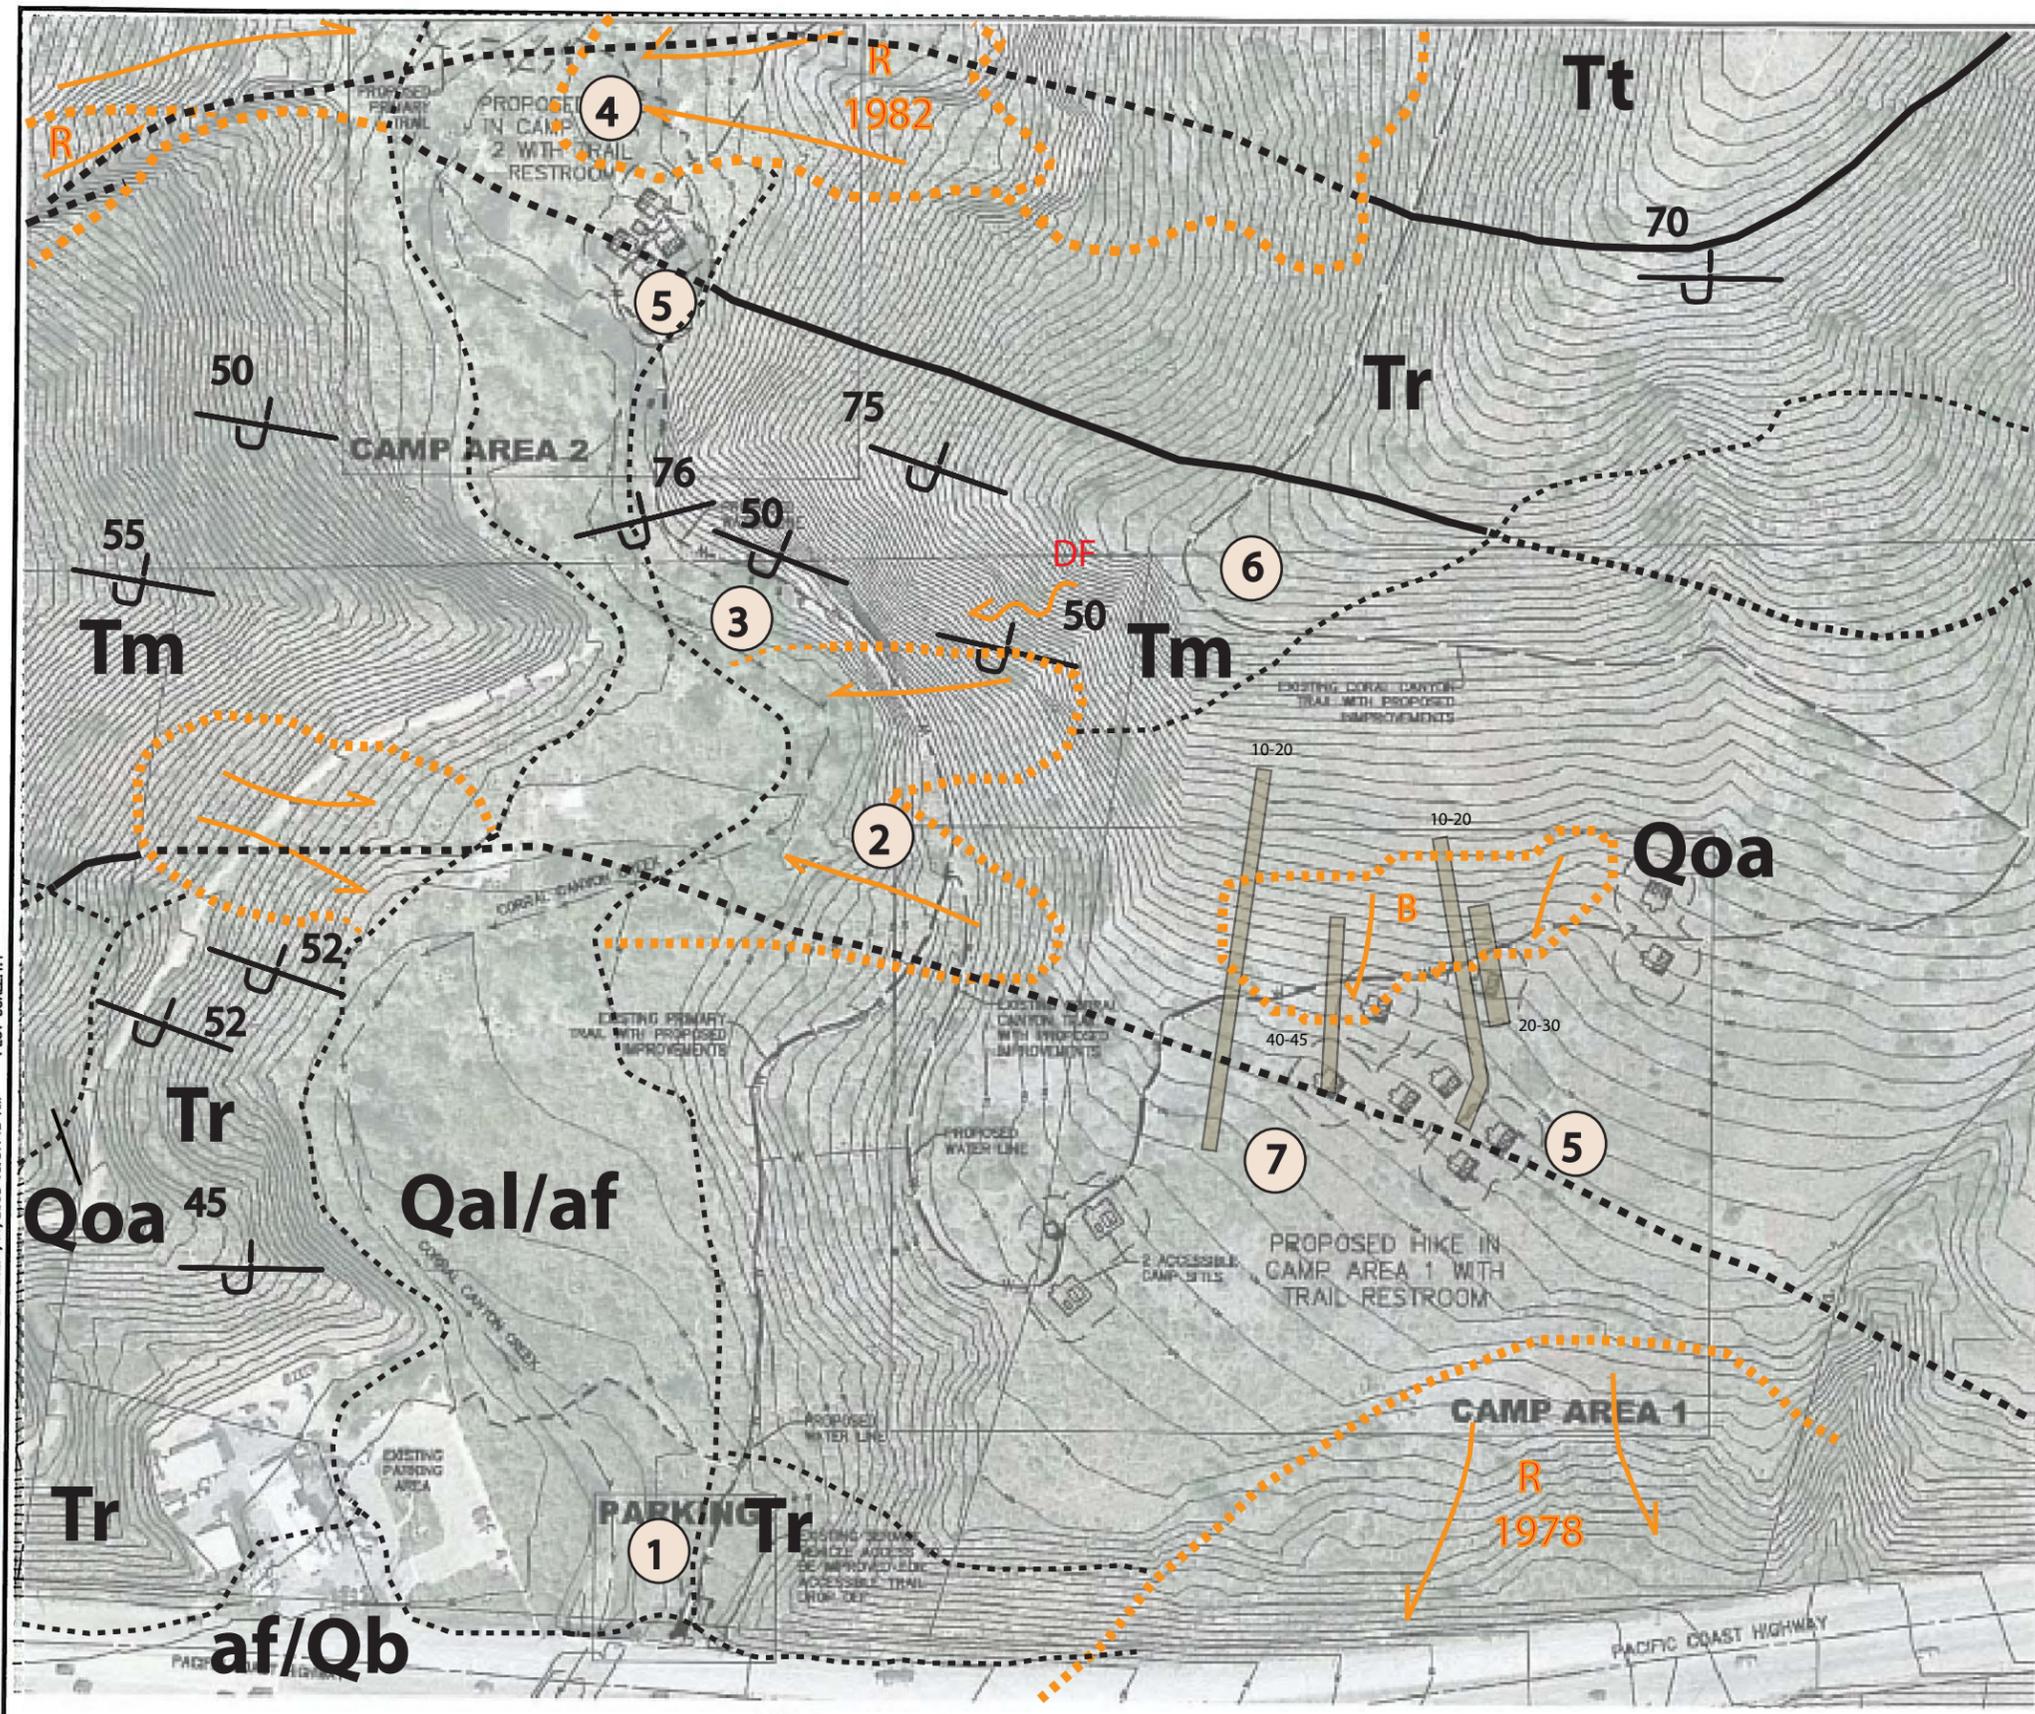
CORRAL CANYON SITE PLAN

- Qal/af - Recent Alluvium
(with artificial fill from 1965 trench excavation- exact location unknown)
- af/Qb - Artificial Fill over Beach Sand
- Qoa - Older Alluvium
- Tm - Monterey Formation
- Tt - Topanga Formation
- Tr - Trancas Formation
- Bedding - Upright
- Bedding - Overturned
- Landslide
R - Recent movement with date if known - movement may be more recent than indicated
B - Buried below younger deposits
- Debris Flow Scar
- Geologic Contact
- Malibu Coast Fault
Various Branches
Dotted Where Buried
- Locality
Described in text
- Exploratory Fault Trench
Showing maximum depths estimated from logs. Excavated in 1965

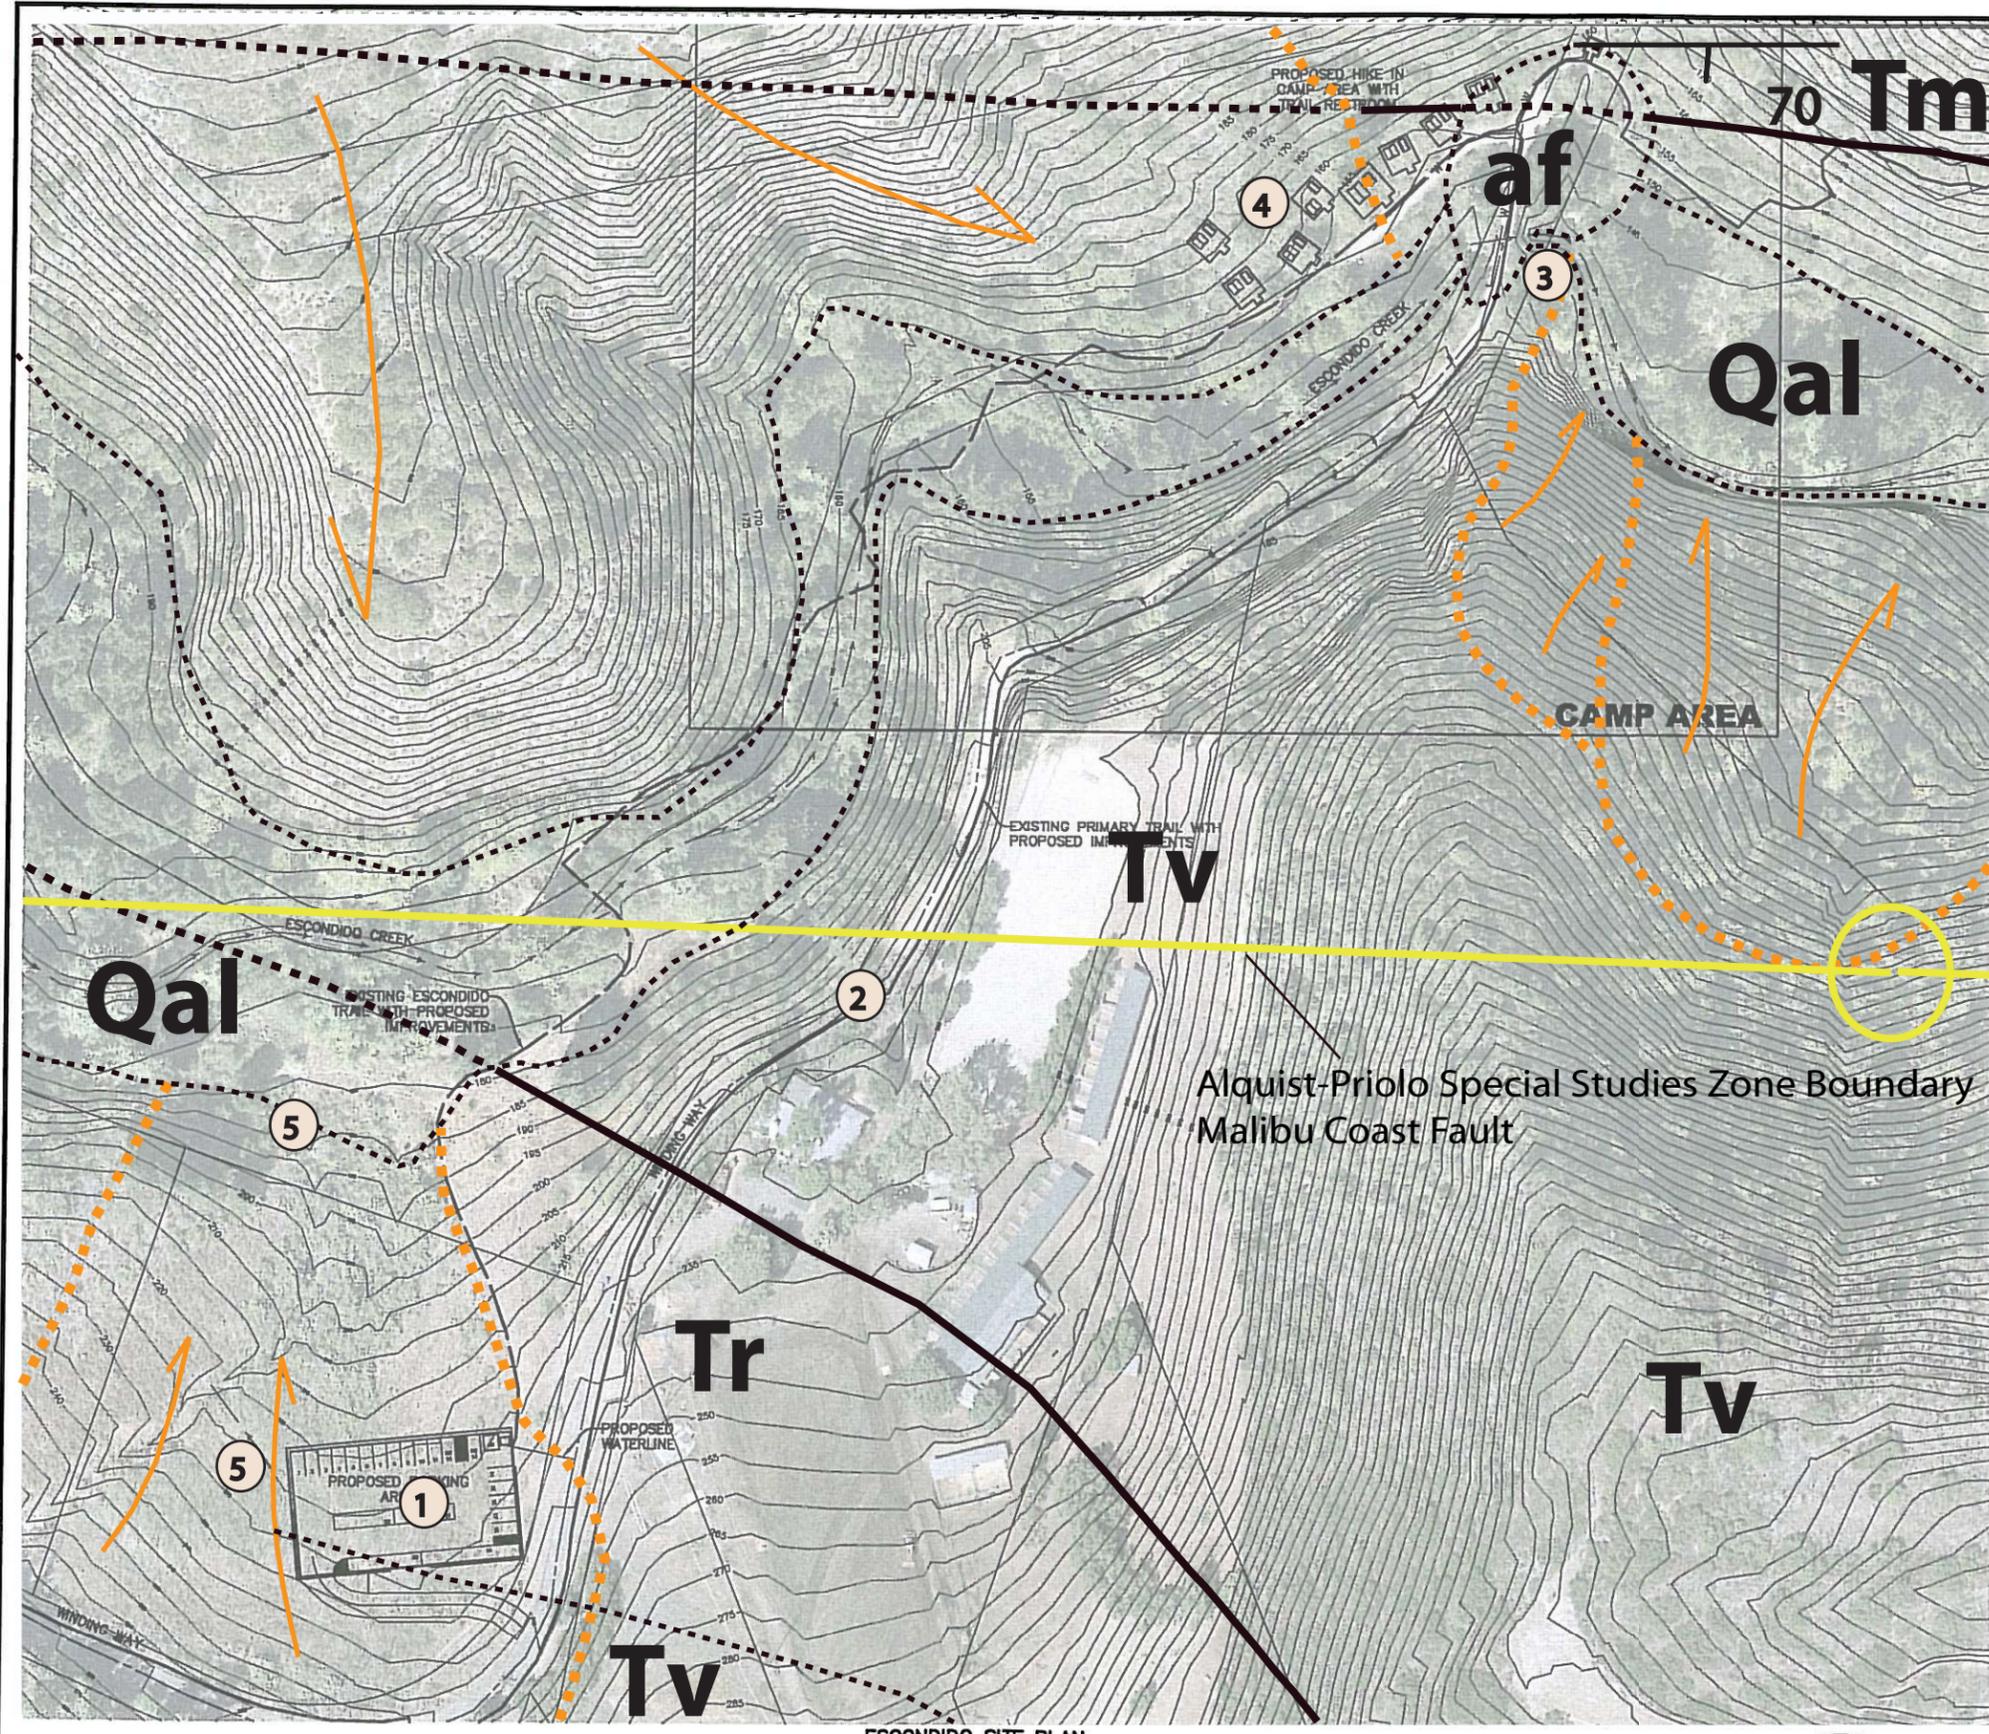
ESCONDIDO SITE PLAN

- Locality
Described in text

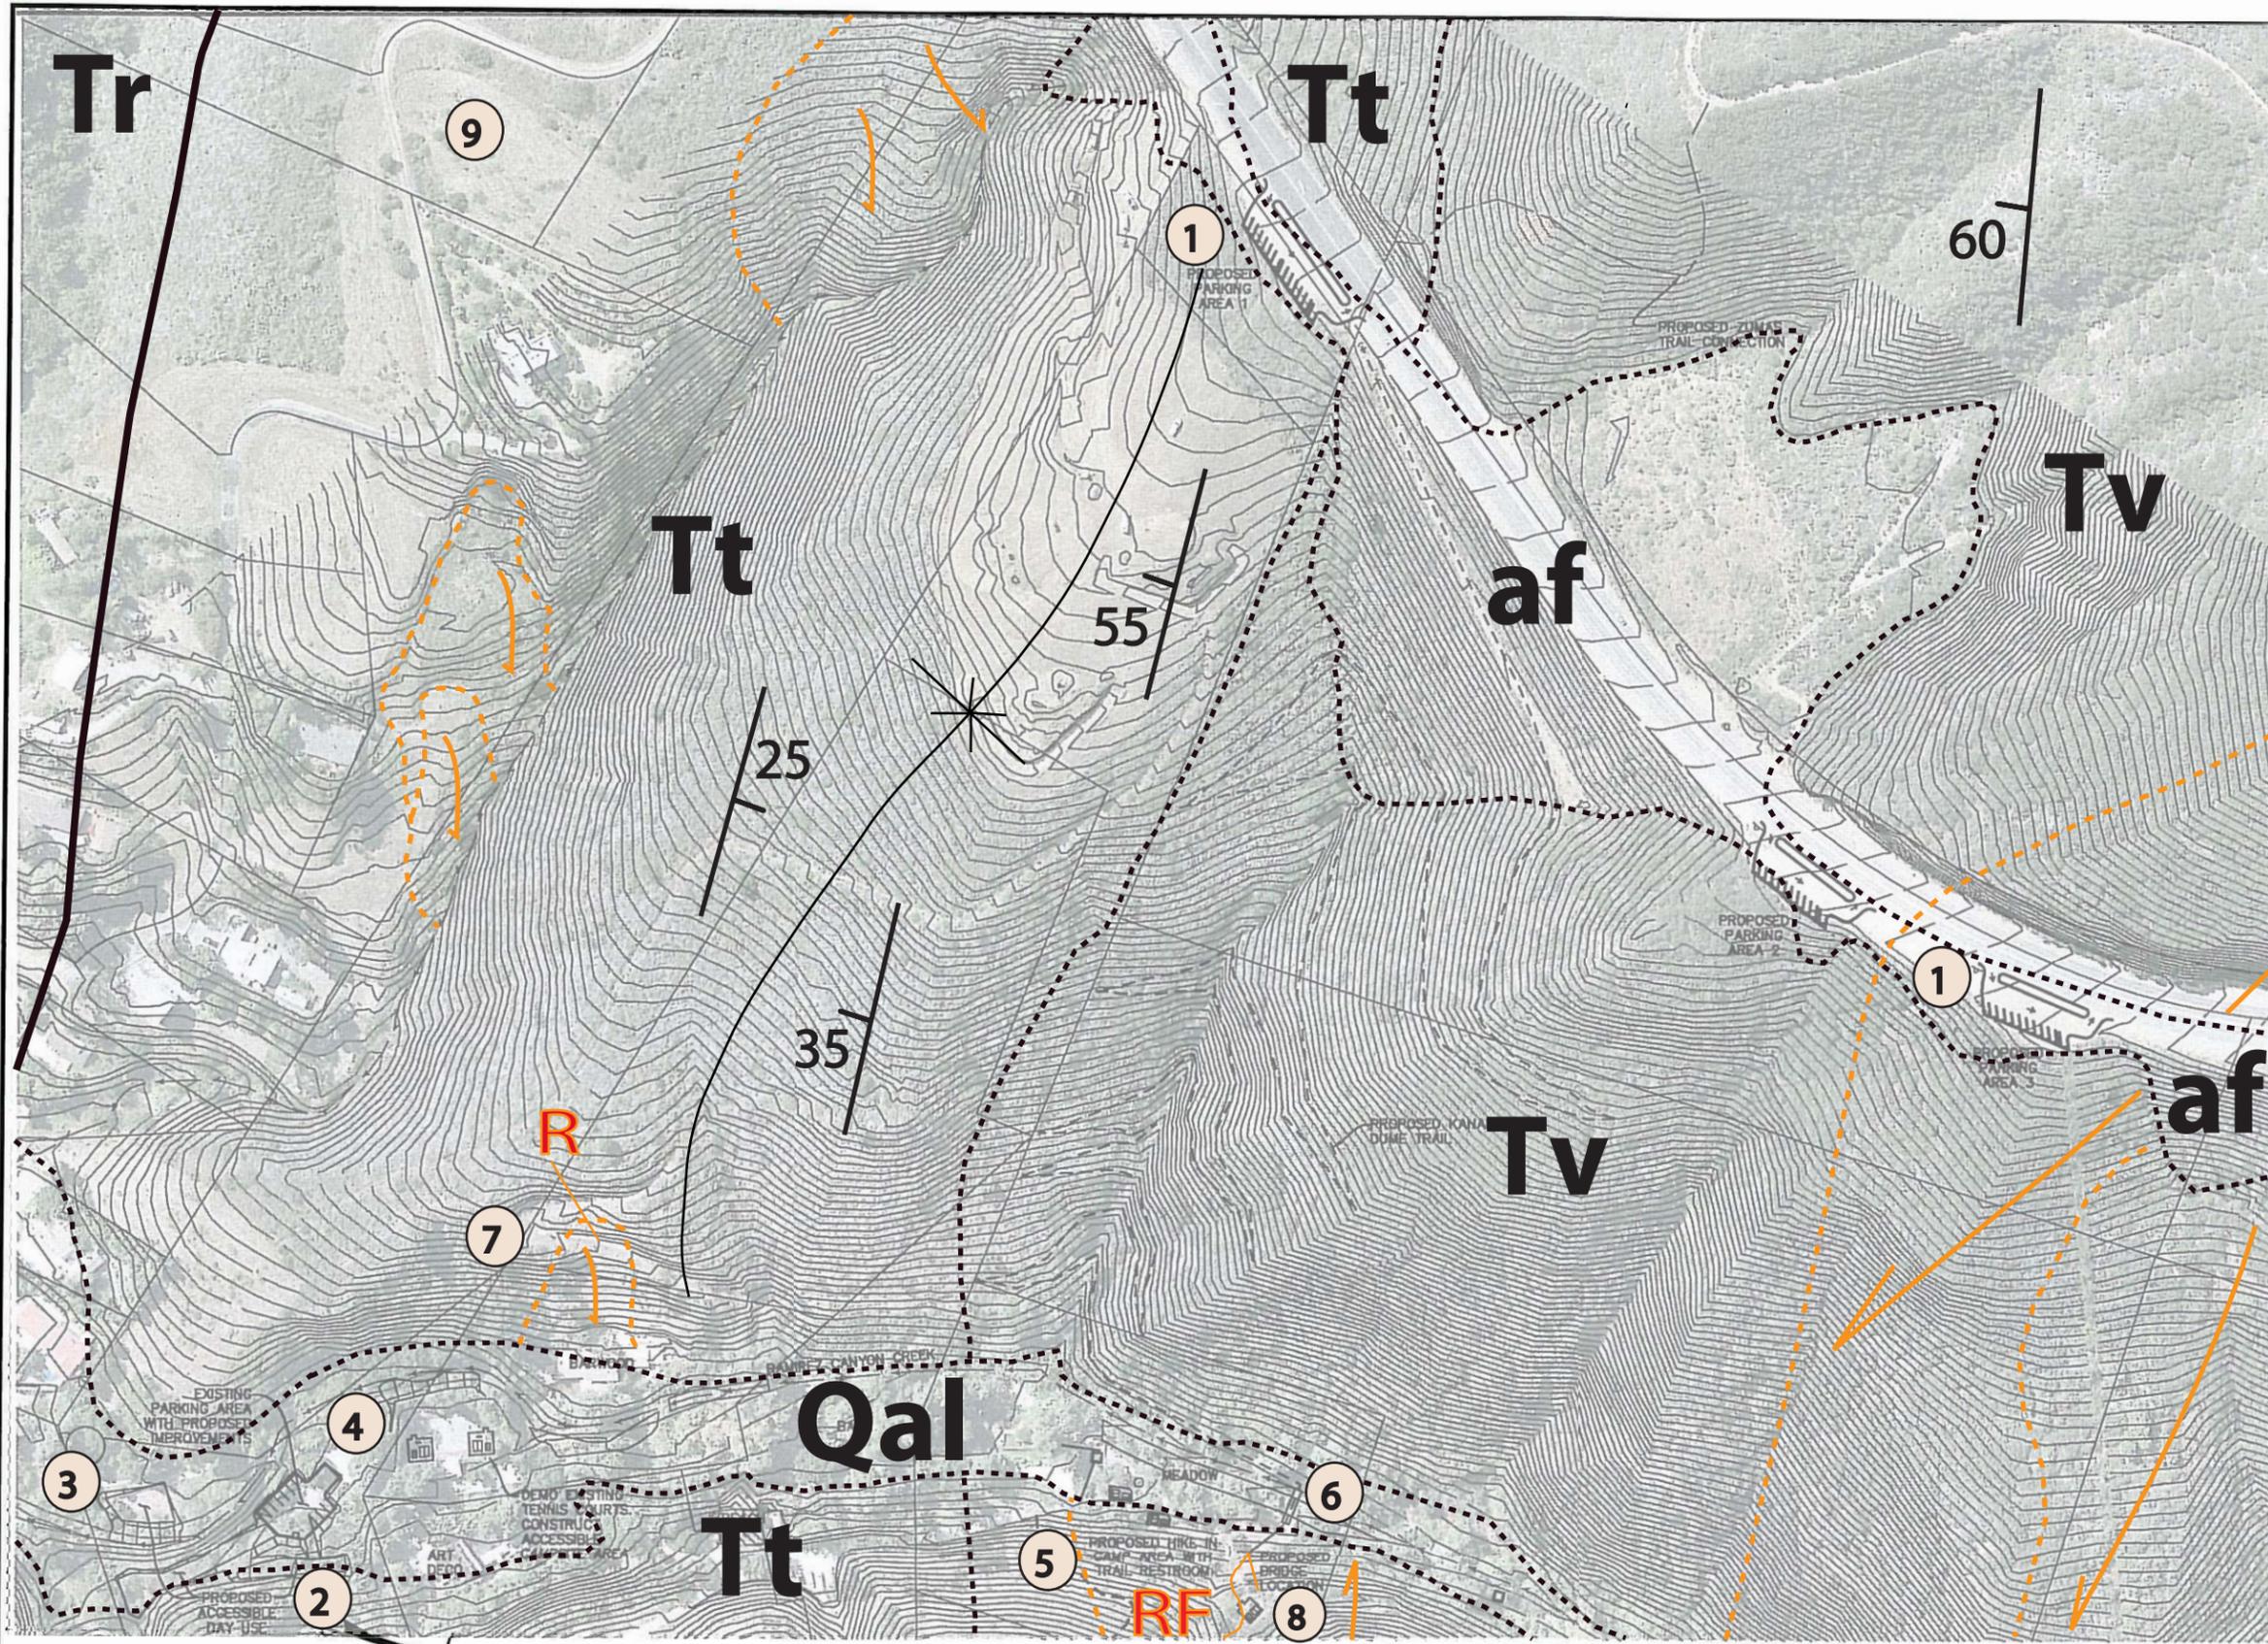
RAMIREZ CANYON AND KANAN DUME ROAD SITE PLAN

- Locality
Described in text

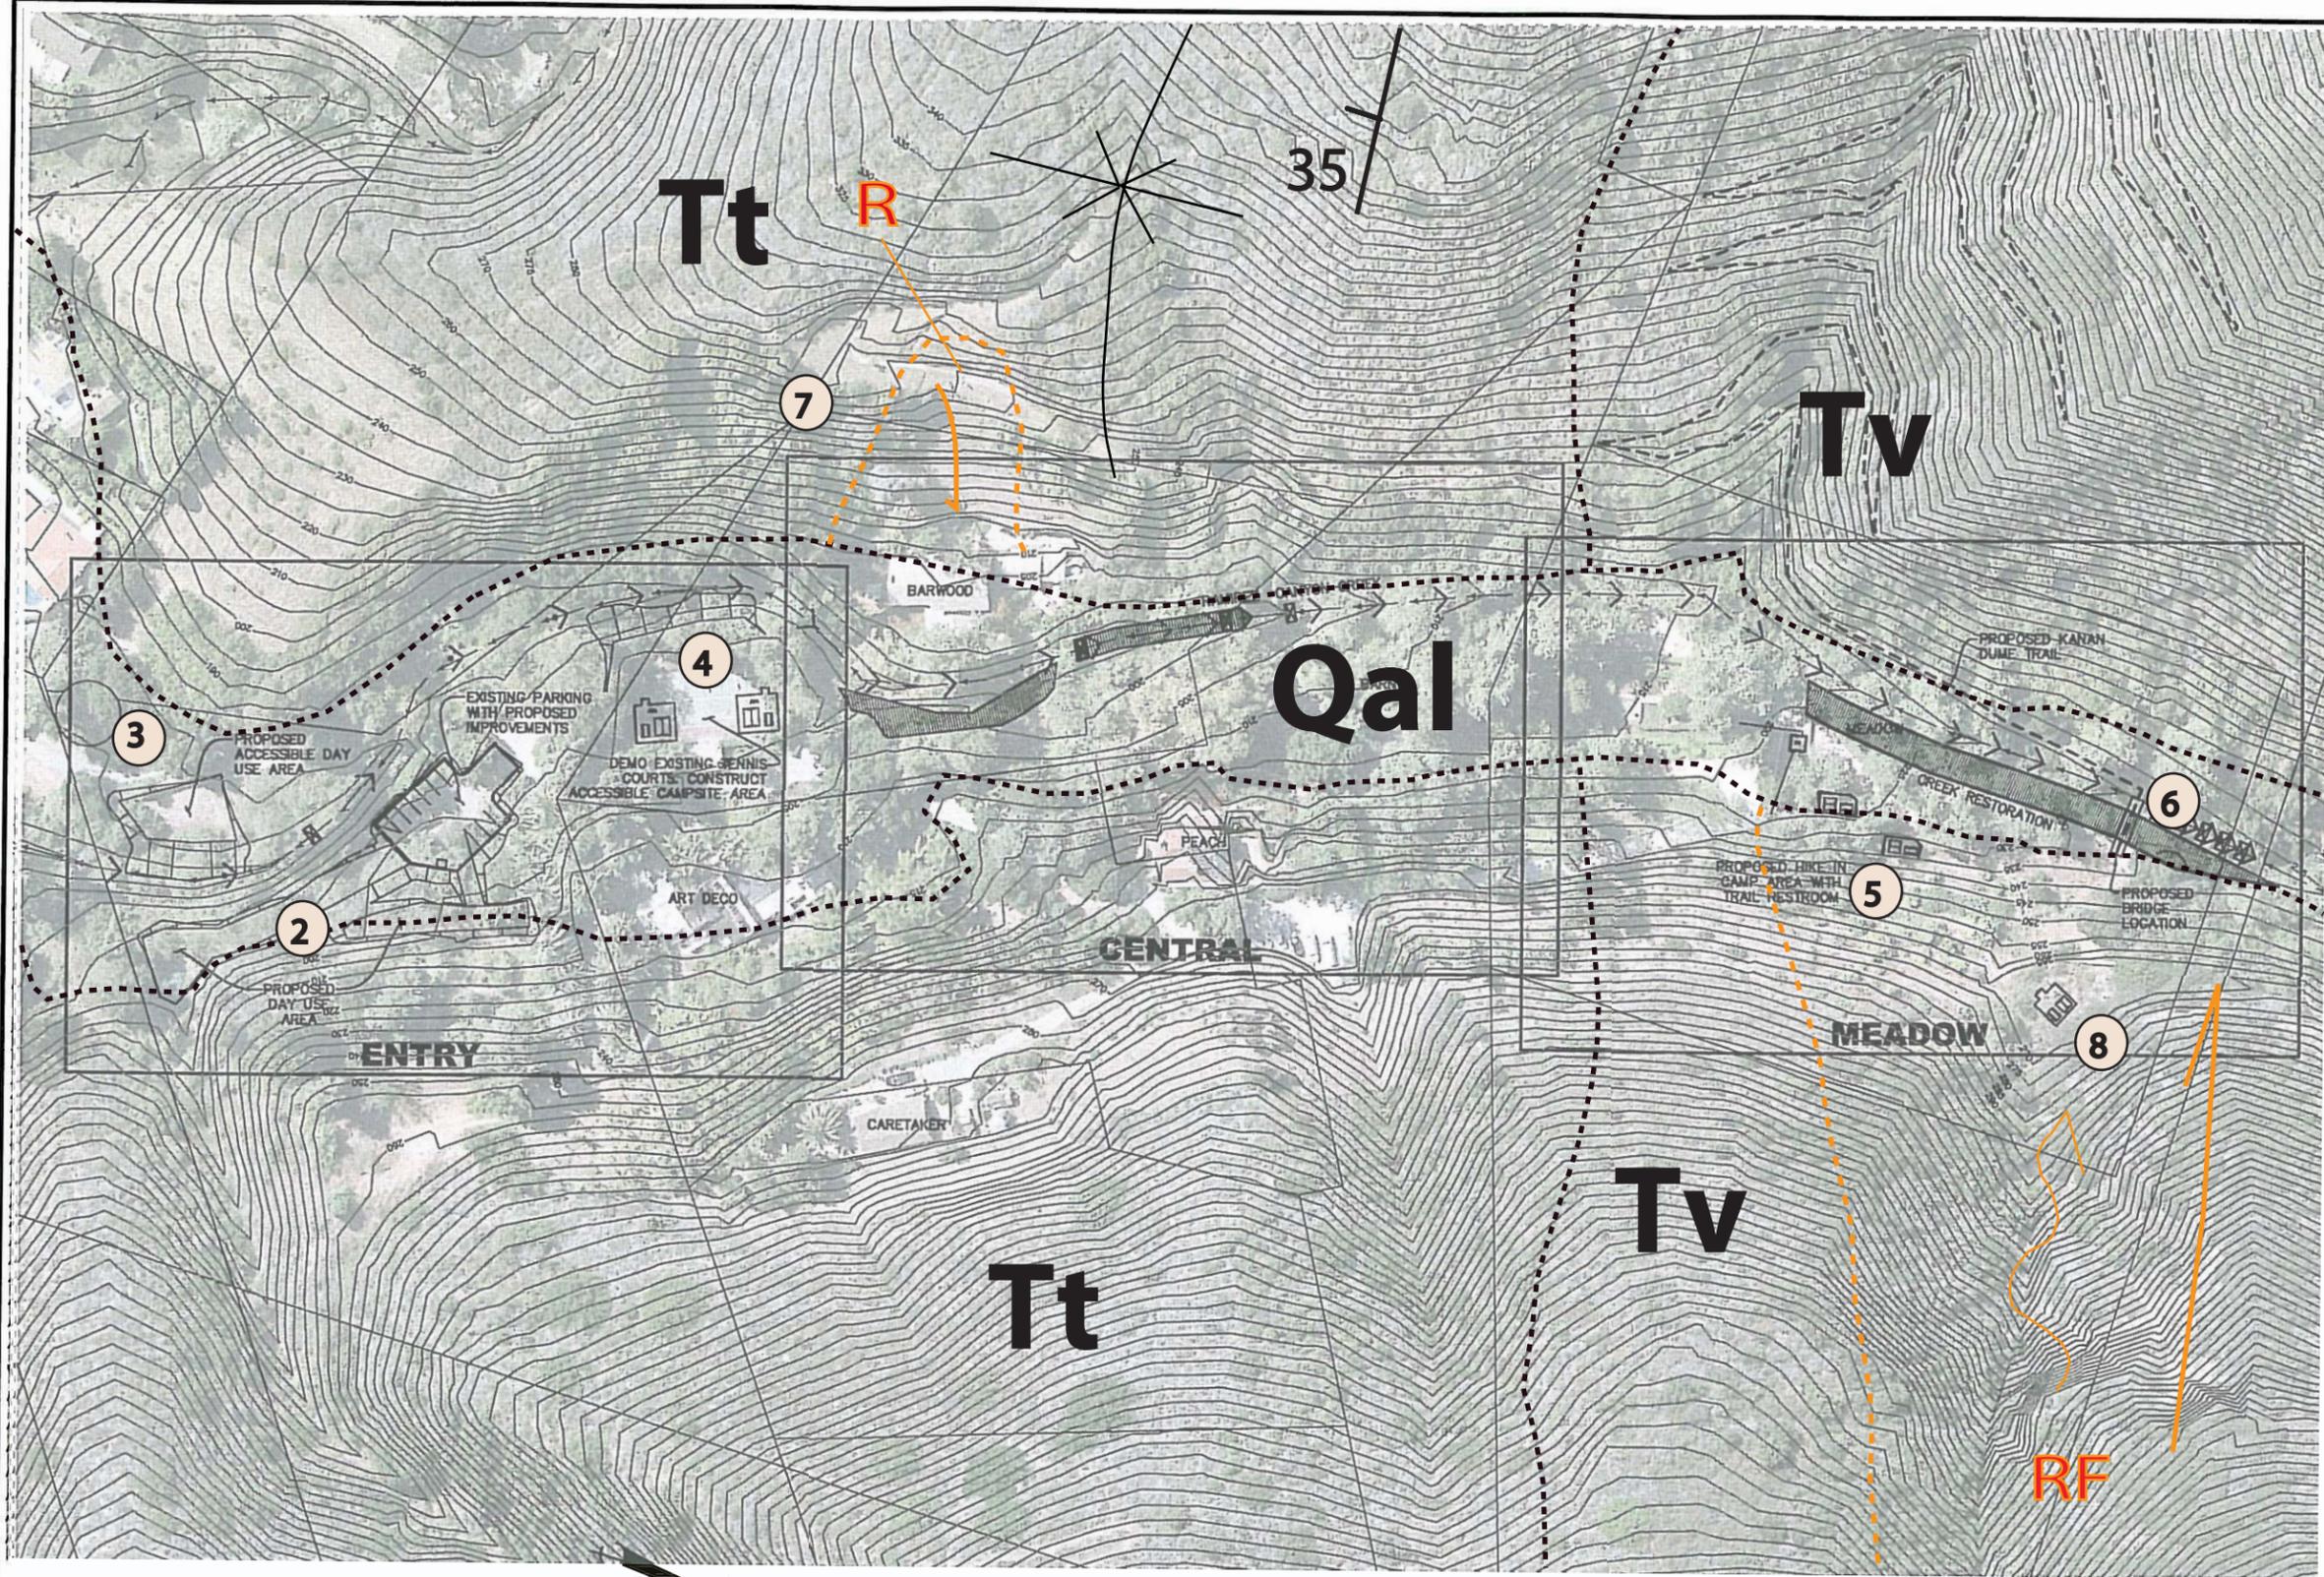
Geologic Map Ramirez Canyon (Sheet 2)

- Qal - Recent Alluvium
- Tt - Topanga Formation
- Tr - Trancas Formation
- Tv - Conejo Volcanics

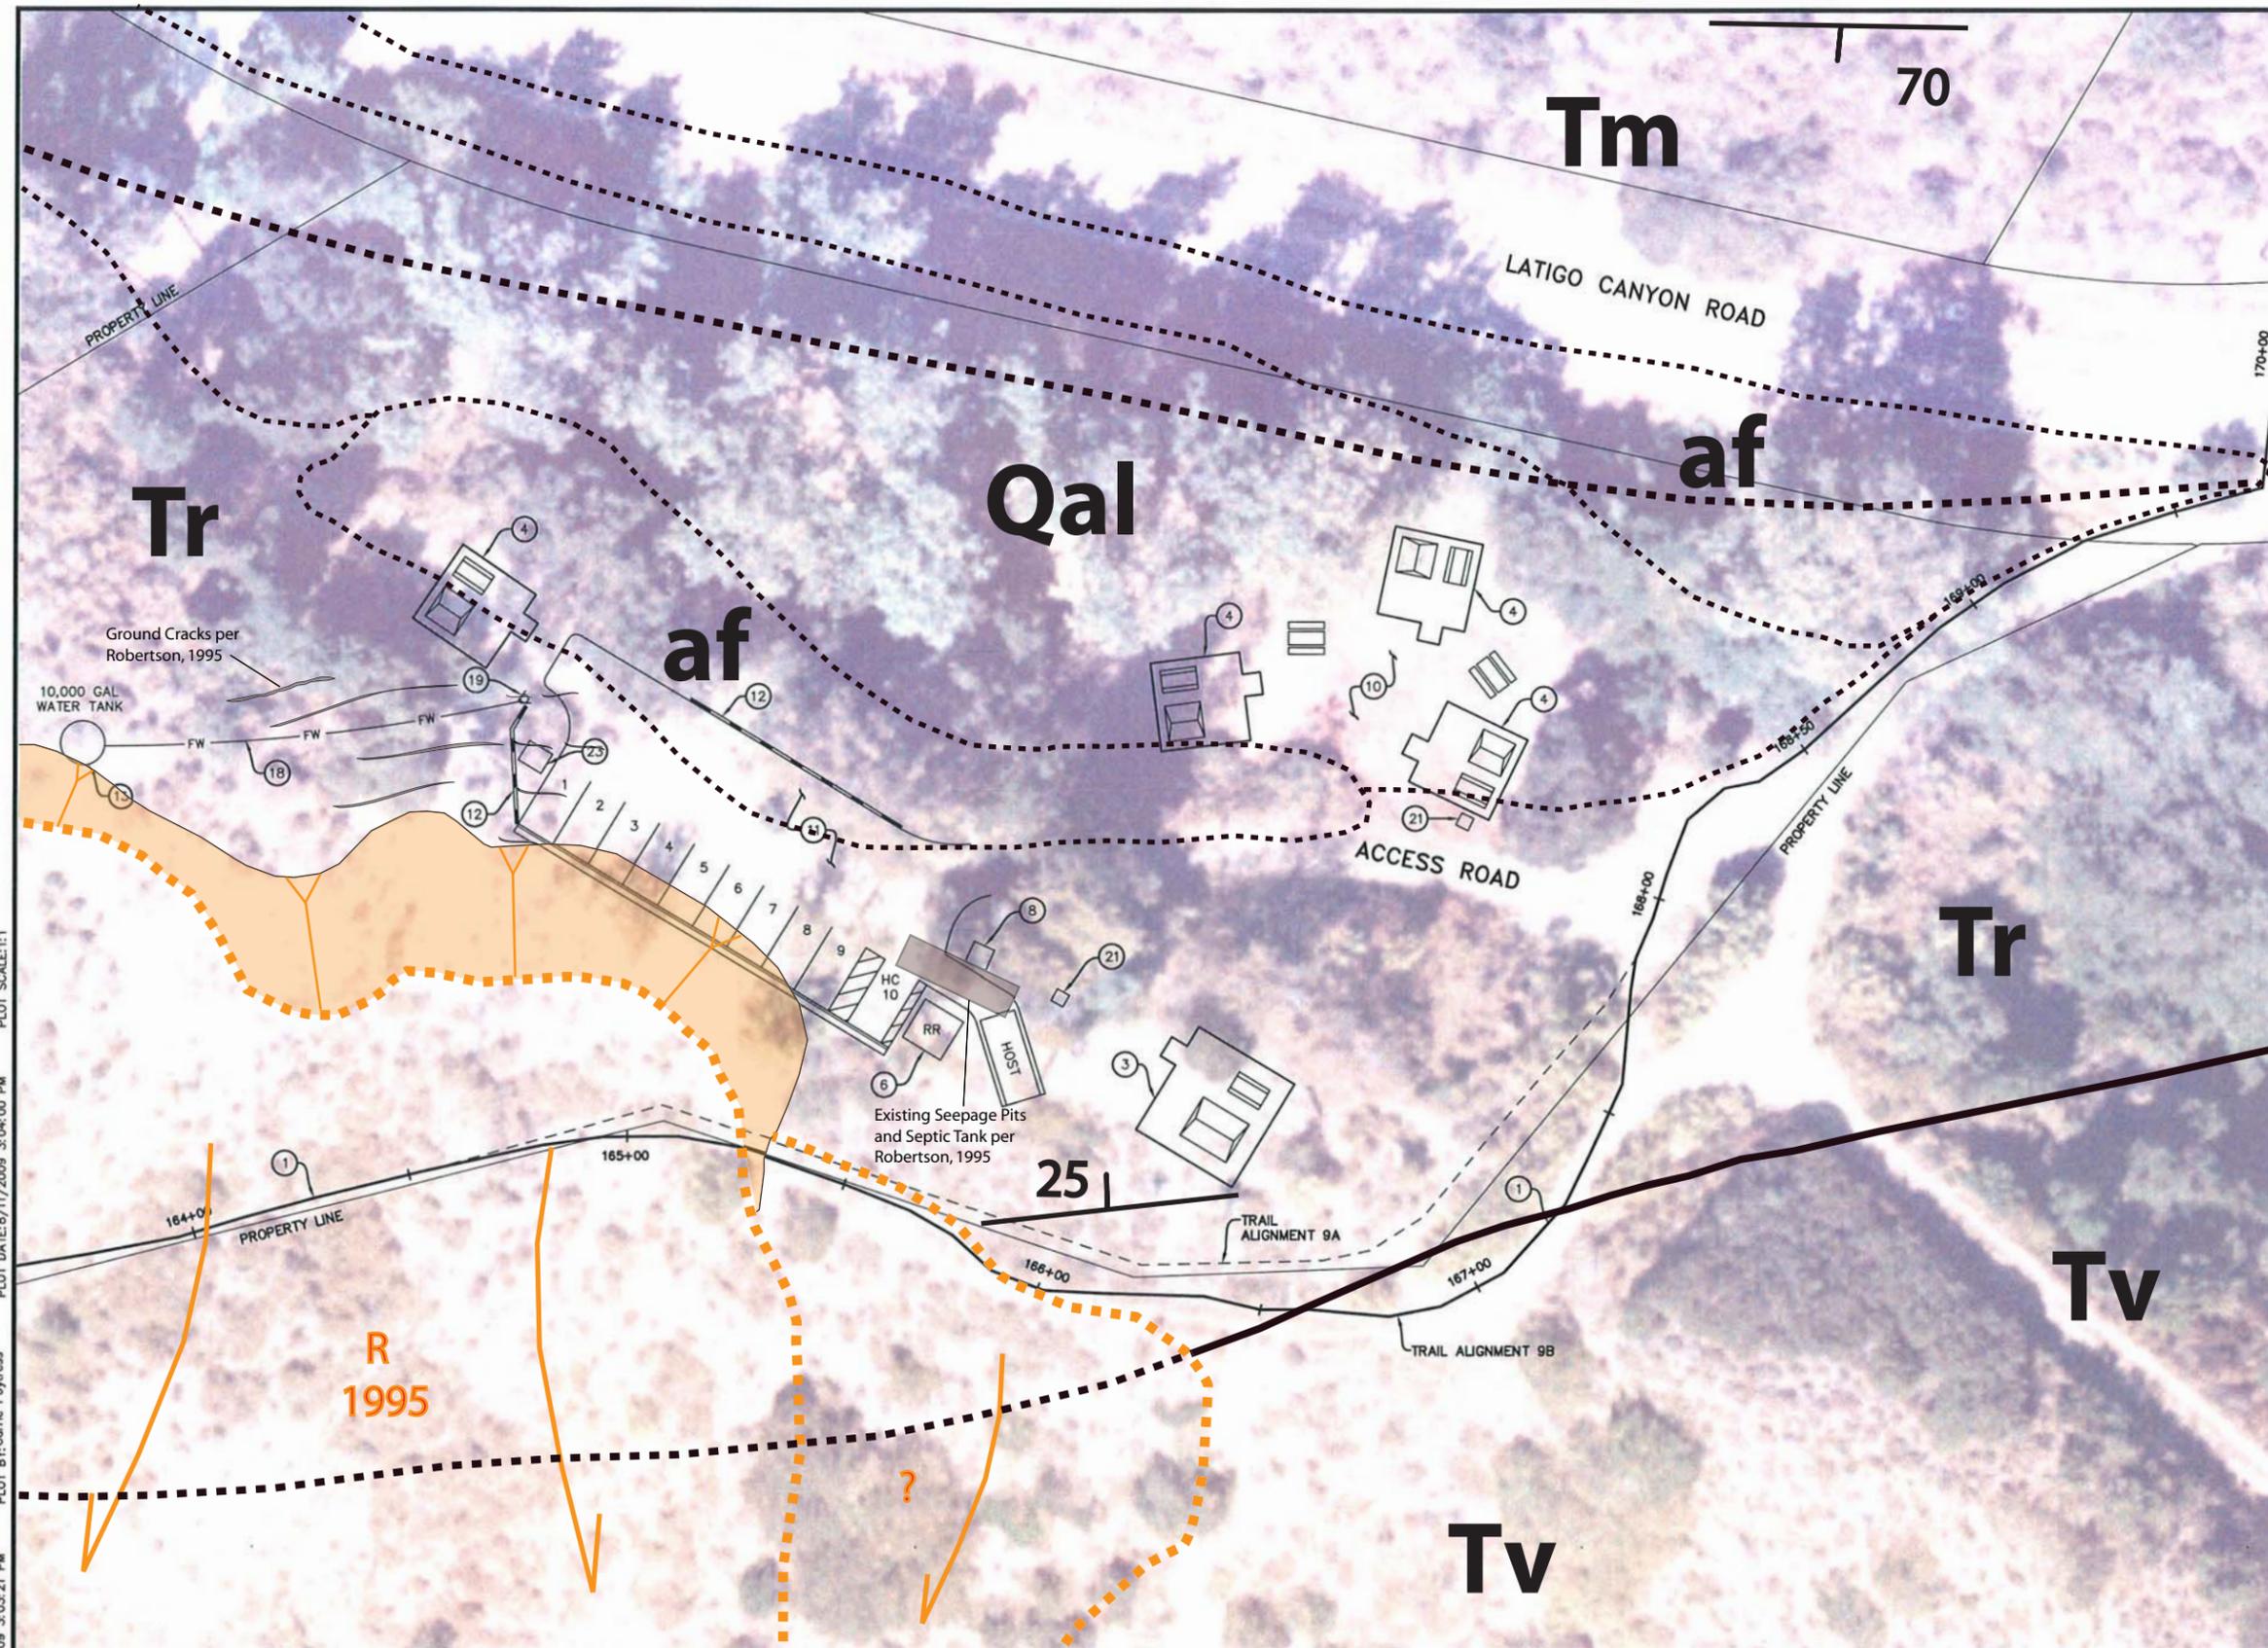
Geologic Map Latigo Parking

- Qal - Recent Alluvium
- Tm - Monterey Formation
- Tv - Conejo Volcanics
- Tr - Trancas Formation
- af - Artificial Fill
- Bedding
- Landslide
Shaded area indicates well-defined headscarp inclined at 60-80 degrees
R - Date of original failure
periodic/creeping movement
likely continues
? - Questionable
- Geologic Contact
- Malibu Coast Fault
Various Branches
Dotted Where Buried

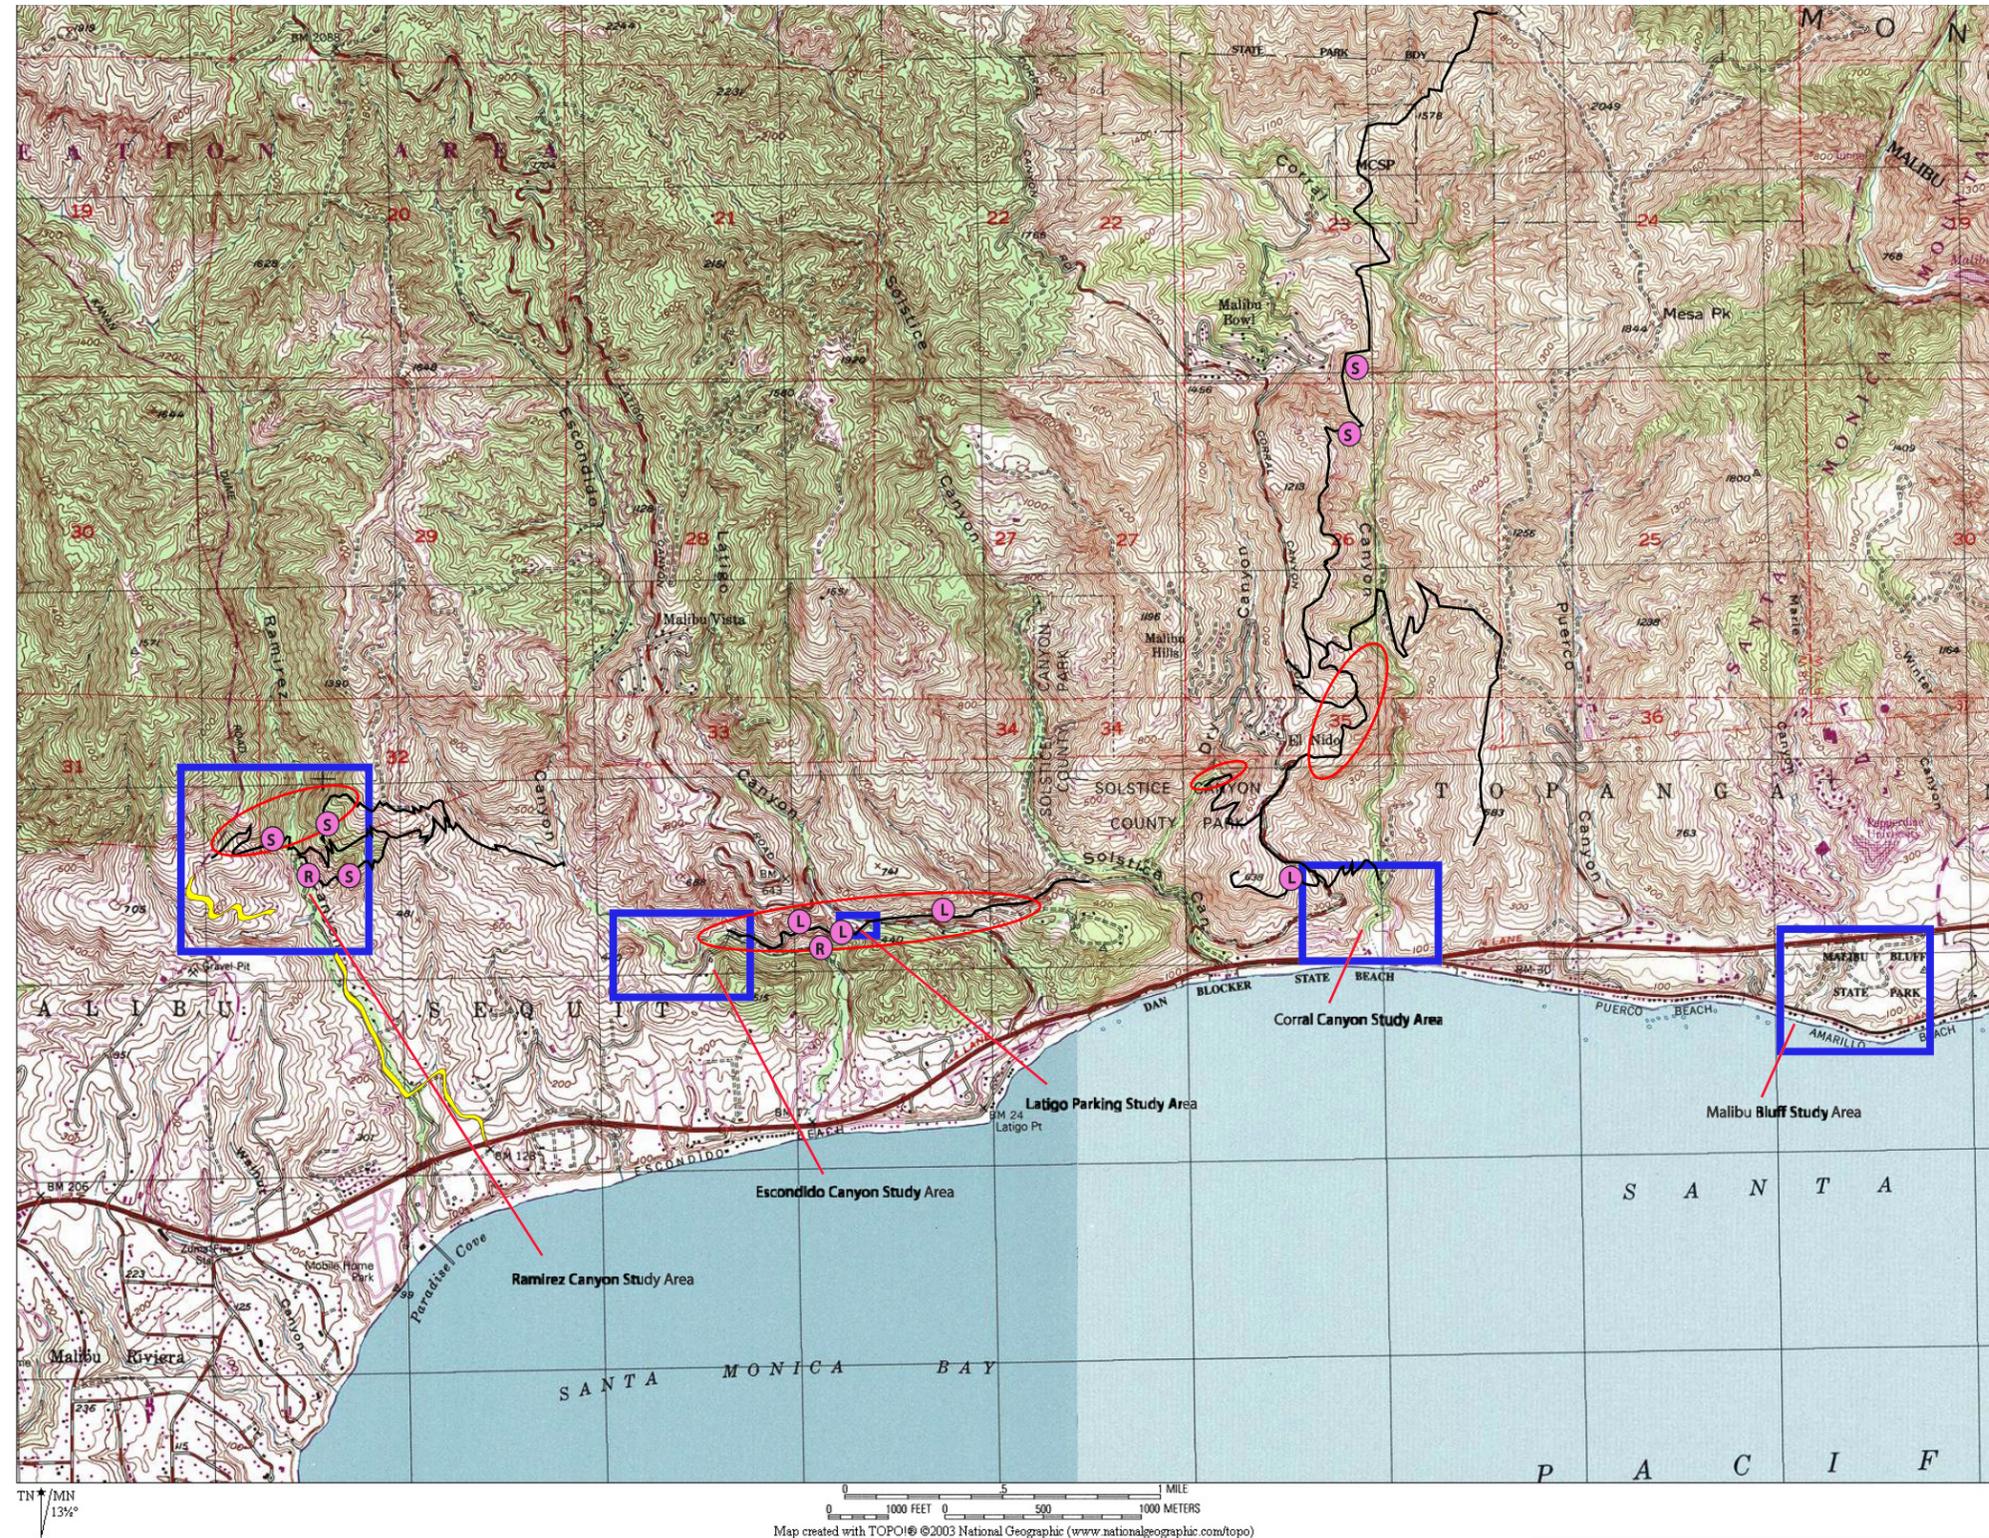
Figure 1

Proposed Trail & Access Map
