Chipping Concrete, Finding Water

A NEW GREENWAY,
WITH STREAM, IN TUJUNGA WASH

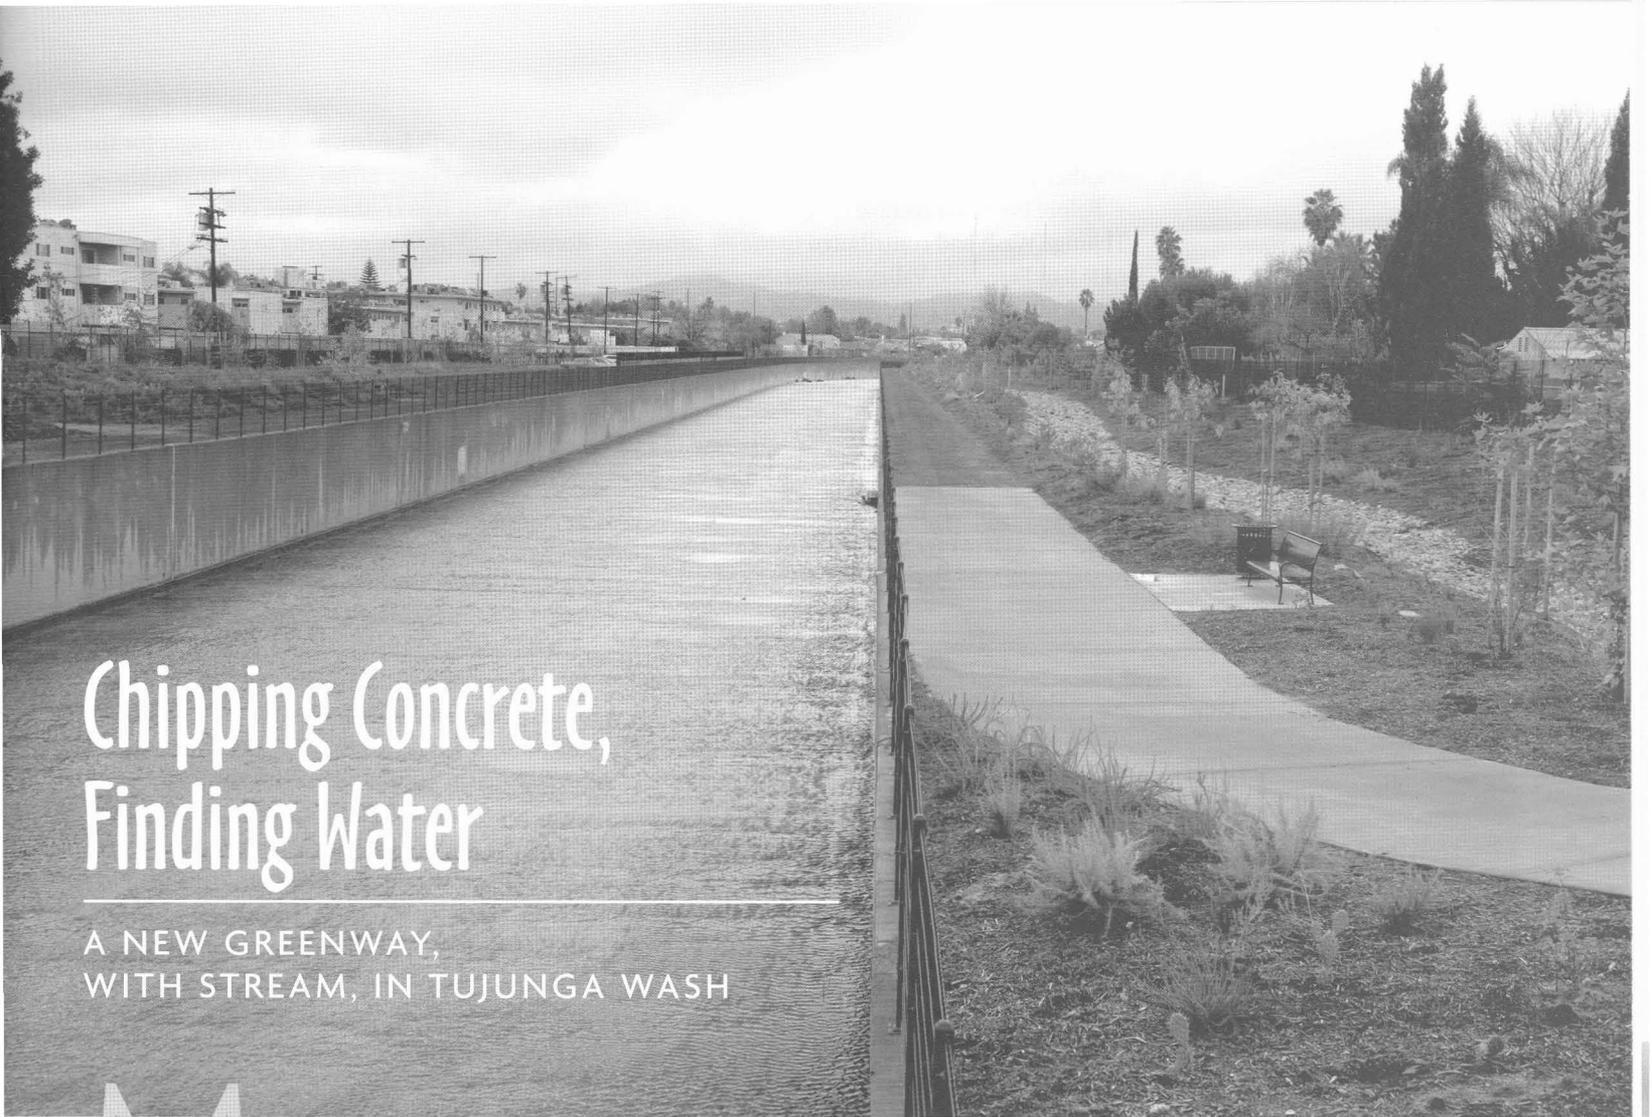
The new stream runs past young trees beside the path, which is mostly gravel.

grams, Elizabeth Jordan, project manager for the greenway, and Dash Stolarz, director of public affairs. “Almost everything here is native,” Romero told us. “We’re trying to create a natural system in an unnatural area by letting plants compete.” Some won’t make it, but that’s part of the restoration process. So are changes in the stream, which was built six feet wide, but has expanded to eight feet in some spots. The water is having its way.

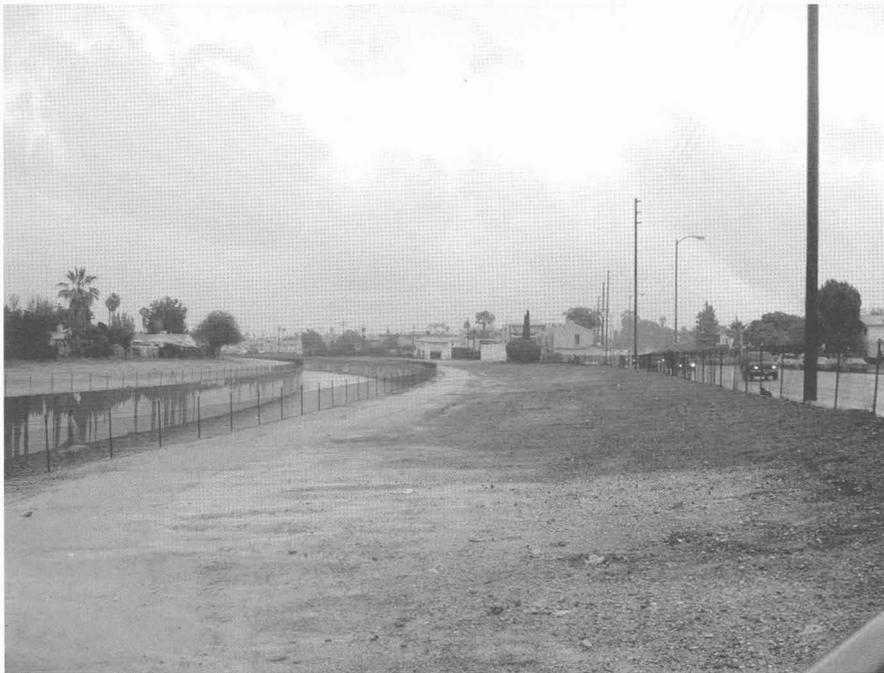
Top: Before the greenway was built, this mile of the Tujunga Wash Flood Control channel looked like its other 499 or so miles. It was flat, flanked by concrete and gravel, and barren.

Before leaving, we crossed Vanowen to look at the flood control channel on the other side, with flat, bare, and bleak banks—a blight on the neighborhood. That’s how the site of the greenway looked not long ago. The Los Angeles Flood Control District manages 500 miles of open channels. We had seen the first of what could be many greenways.

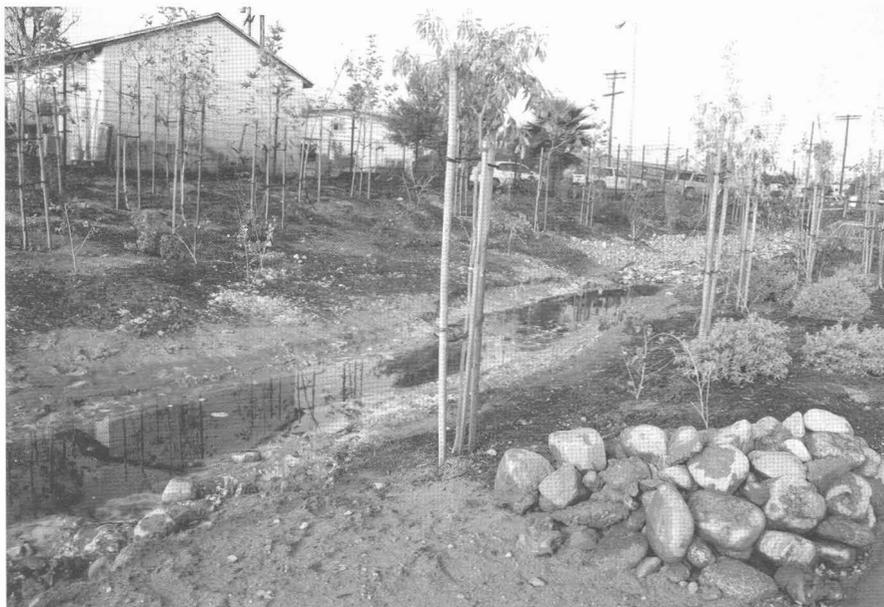
Bottom: A closer view of the stream
